## 3D THICKNESS MEASUREMENT TECHNIQUE FOR CONTINUOUS CASTING BREAKOUT SHELLS

In this paper, the breakout shells from two incidents at the high speed thin slab caster at the Direct Sheet Plant (DSP) are discussed. The first breakout is related to entrapment of a large inclusion on the wide face. The second is a narrow face breakout related to localised shell thinning and incorrect taper settings.

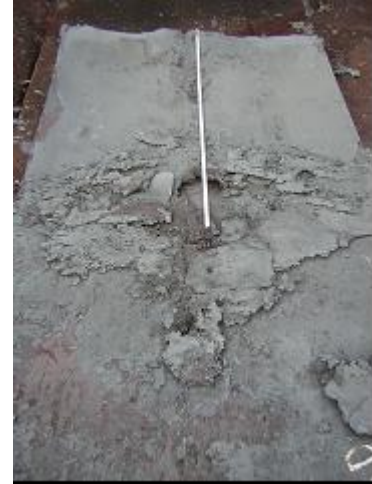
*Figure 3. Breakout shell (loose side)*

*Figure 3* shows a photo of the breakout shell used for further analysis.

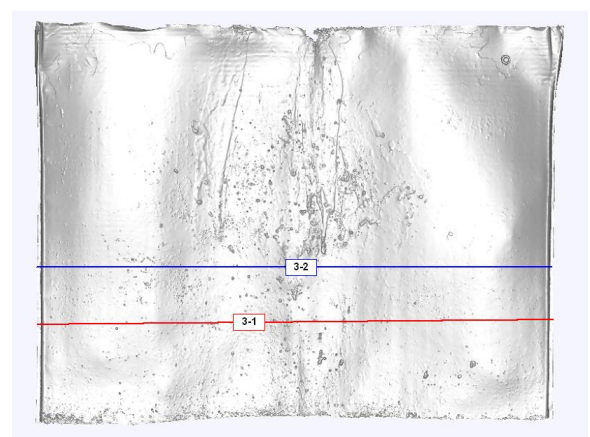
*Figure 4. The half-breakout shell under study. Lines blue and red are used for the thickness-plane measurements.*

Due to the breakout hole and some splashes attached to this breakout side of the shell, the opposite side of the breakout was used in the laser measurement. Therefore, the full fixed face side and half of both narrow sides were used for the measurement. *Figure 4* shows the half-breakout shell under study.

To be able to clarify the reduction in thickness, two positions were used to measure the shell thickness along a line (lines in red and blue in *Figure 4*).

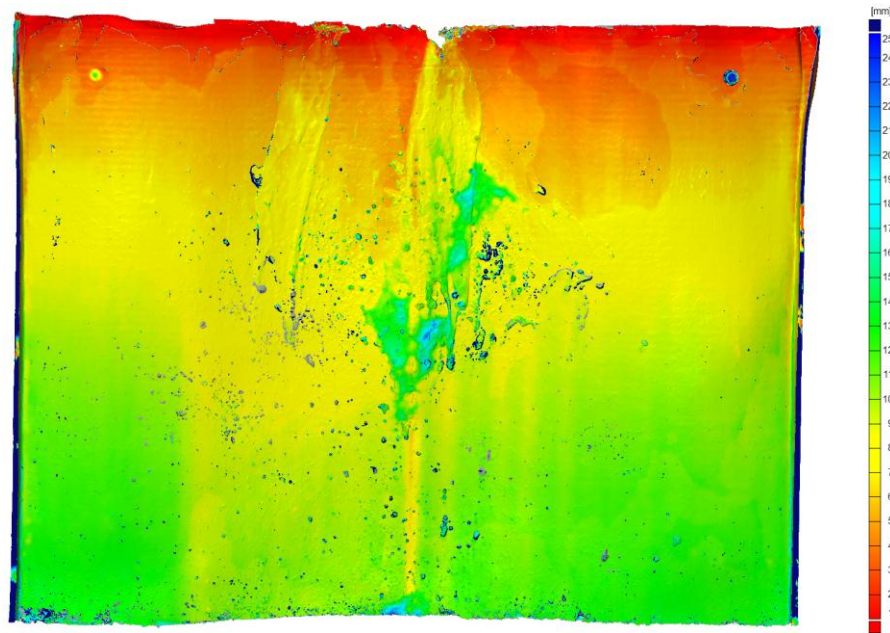
Figure 5. A 3D view of the shell thickness.

A 3D view of the shell thickness is shown in *Figure 5*. In this image it is noticeable that the breakout shell has no constant thickness and displays three kinds of thinning:

- local thinning in the longitudinal direction
- local thinning in the vertical direction
- thinning in areas of the shell

The localised reduction in the thickness is about 50%, compared with other areas; especially in the longitudinal direction.

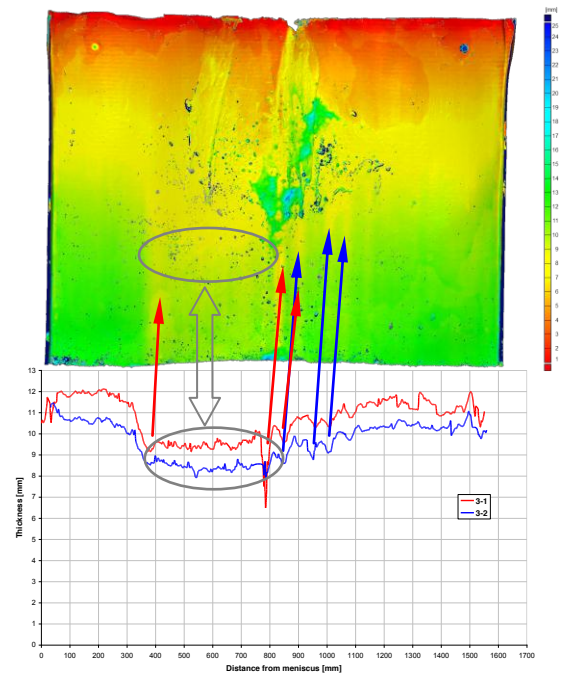
Figure 6. Results of the line measurements compared with the 3D view.

Results of these positions compared with the 3D view are shown in *Figure 6*.

The lines show more clearly the reductions in thickness of the shell, indicating the localised and areal thinnings.

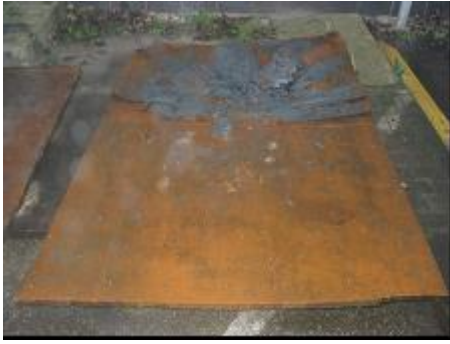
Figure 7. Breakout shell.

Consequently, after the breakout event, the breakout shell was put aside for further analysis, and the breakout shell was studied and its thickness measured with the 3D laser technique. *Figure 7* shows a photo of the breakout shell.

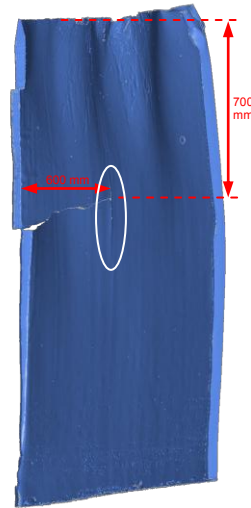
Figure 8. Half-breakout shell under study. Into the white oval the LFC is shown.

Figure 8 shows the half-breakout shell under study. In the middle of this half-shell a longitudinal crack was found (circled in white). In red the distances of the crack to meniscus and from the south narrow face are shown.

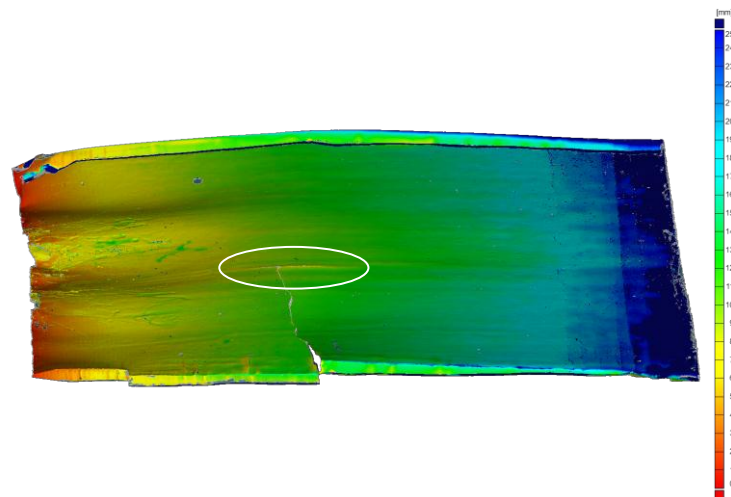
Figure 9. A 3D view of the shell thickness.

A 3D view of the shell thickness is shown in Figure 9.

In this image it is noticeable that the breakout shell has no constant thickness and again displays the same three kinds of thinning as in breakout A:

- local thinning in the longitudinal direction
- local thinning in the vertical direction
- thinning in areas of the shell

The localised reduction in thickness is also about 50% , compared with other areas; especially in the longitudinal direction (longitudinal crack).

In figures Figure 9 and Figure 10, the longitudinal crack is marked with a white oval. The transverse crack in this breakout occurred during the extraction of the breakout shell from the machine because the extraction of the shell was done from the top of the mould; however it obviously had a transverse local thinning of the shell in the corner region to initiate this cracks (thinning marked in Figure 11, blue line).

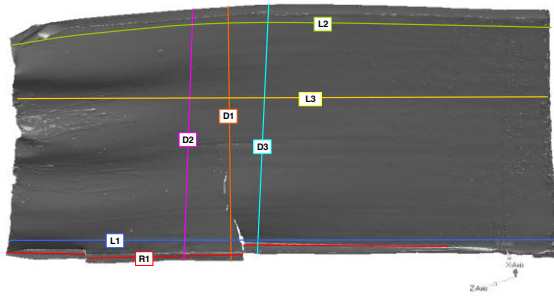
Figure 10. Schematic representation of the sections for thickness measurement.

Two sets of positions were chosen in part of the breakout, three in the transverse direction and three in the longitudinal direction. In Figure 10 a schematic view of the line's positions is shown.

- R1 (red line): longitudinal plane in the narrow face (south), about 15 mm from the corner.
- L1 (blue line) and L2 (green line): also longitudinal sections, approximately at 15 mm from the corner, L1 close to the south narrow face and L2 close to north narrow face.
- L3 (dark yellow line): Longitudinal section to compare the thickness of the shell between the middle and the sides of the slab.
- D1 (orange line): in the middle of the longitudinal crack
- D2 (pink line) and D3 (turquoise line): both at end and beginning of the crack, respectively.

To evaluate the depressions, three of the seven previous sections (from *Figure 10*) were chosen for this plane cut analysis.

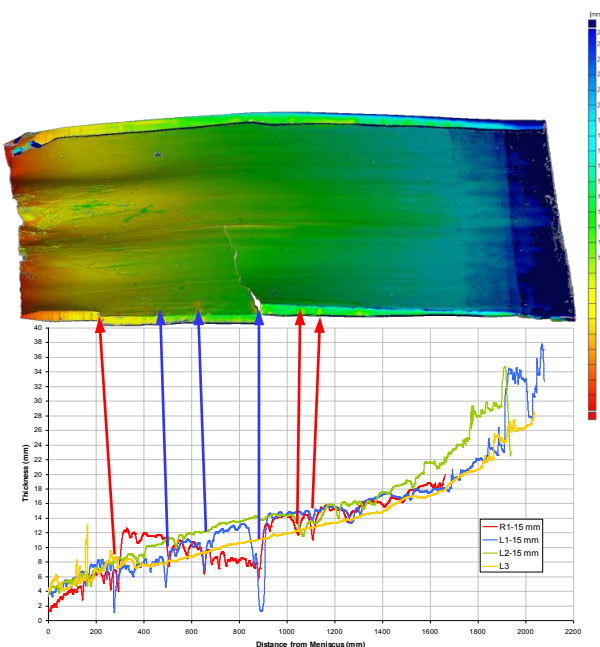
Figure 11. Results of the longitudinal sections compared with the 3D view

Results of these positions compared with the 3D view are shown in *Figure 11* for the longitudinal sections and in *Figure 12* for the transverse sections.

Again the lines show more clearly the reductions in thickness of the shell, indicating the localised and area reductions.

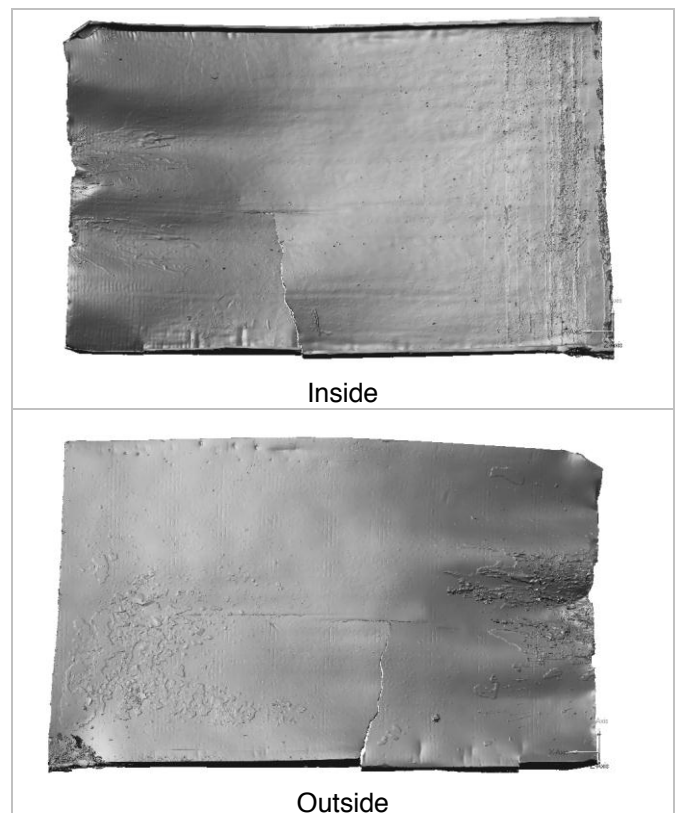
Figure 13. Surface profile of the breakout shell

The 3D laser measurement has also the possibility to evaluate the surface profile (smoothness) of the breakout shell (*Figure 13*).

Considering the localised reductions in thickness of the shell, it is interesting to see the inside and outside surface profiles of the breakout shell.

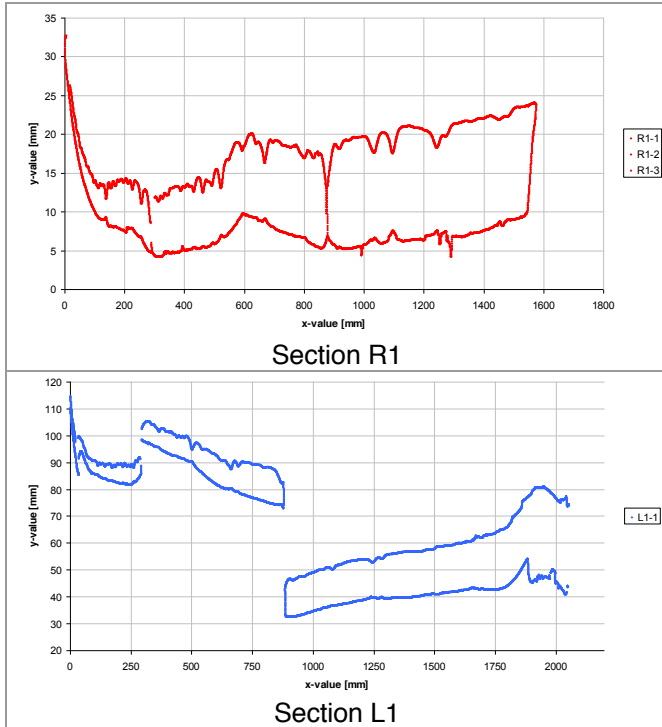
*Figure 14. Plane thickness measurement*

In *Figure 14*, the two sections close to the breakout hole, R1 and L1, both show that the thinning of the shell (depressions) comes from the inside of the breakout.

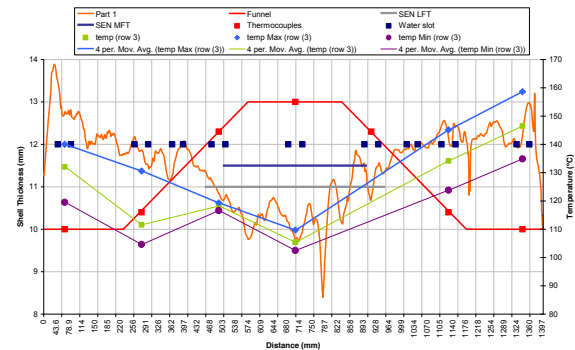
*Figure 15. Thermocouples signals compared with the shell thickness measured.*

In *Figure 15*, the average value of the thermocouple signals during a period of 3 minutes (green line and green points), maximum (light blue line and light blue points) and minimum values (magenta line and magenta points); are compared with the shell thickness measured in the breakout shell (orange line from *Figure 10* and *Figure 12*).

In the figure the position of the water slots and Berthold sources (dark blue squares), funnel shape (red line), position of the thermocouples (red squares), position of the two SEN's types normally used (Grey and dark blue lines) are also drawn.

From this picture it is clear that the thermocouples signals follows the same trend as the shell thickness. However there is no correlation with the shell thickness or the thinning and the mould features (water slots, Berthold, thermocouples position or funnel shape).

Considering that the shell thickness in both breakouts follows the same trend as the thermocouple readings, the most plausible explanation for the shell thinning is a low heat conductive layer between the shell and the mould.

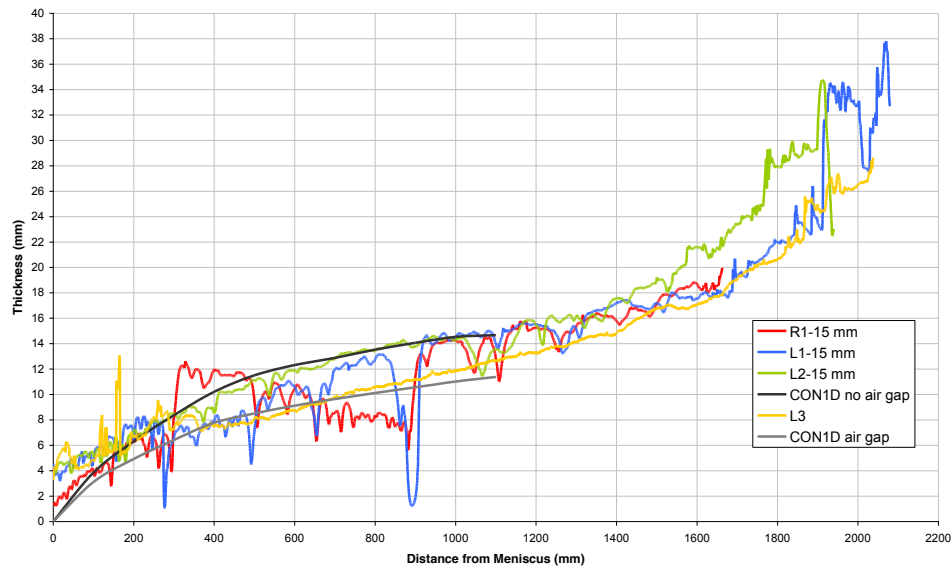
Figure 17. Predicted and measured Shell thickness

Figure 17 gives the predicted shell thickness at both steady state and transient conditions. The generally close match with the transient predictions tends to validate the hypothesis. The underpredicted shell thickness near the meniscus is likely due to a short interval of increased liquid flow into the mould after the breakout started and before level control and flow were shut off. This would have allowed the liquid level to move downward with the top of the breakout shell for a short time interval (not included in the calculations), thus providing additional solidification time at the very top of the breakout shell. This is a very commonly observed effect in breakout shells [3].
