Will be submitted to *ISIJ International*

Large Inclusions in Plain-Carbon Steel Ingots Cast by Bottom Teeming

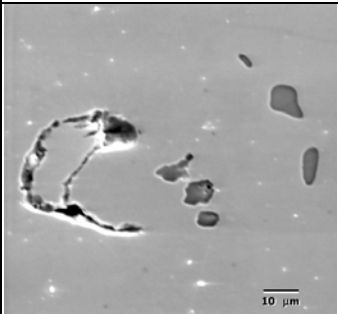
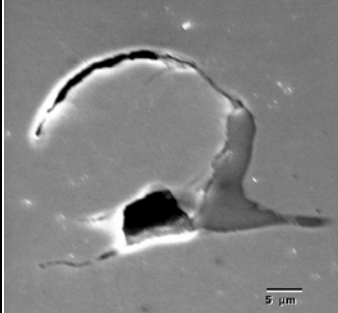
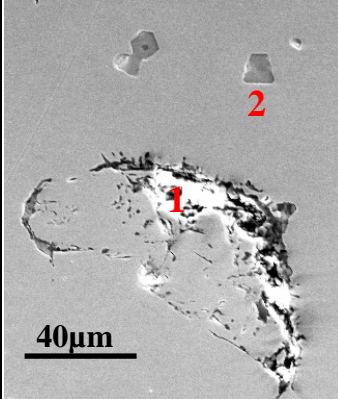
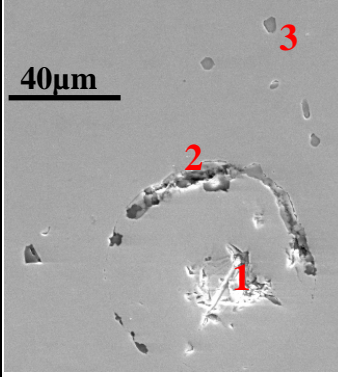
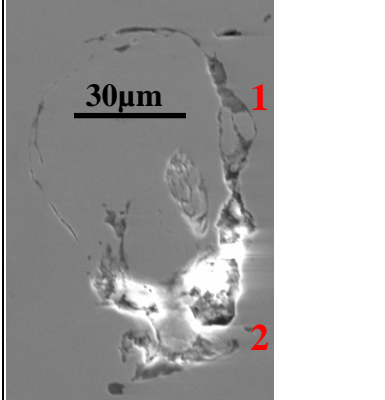
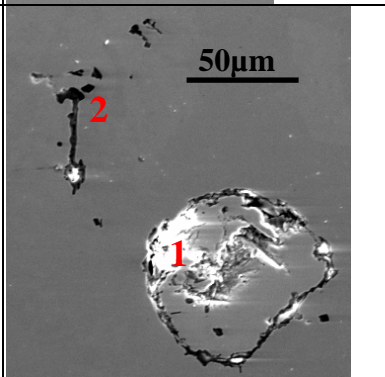
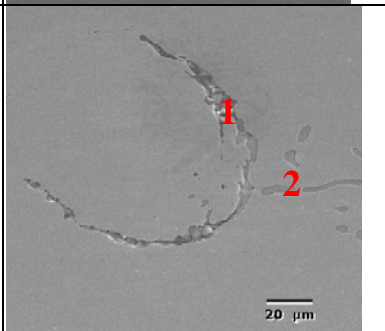
Table 4 Bubble-shaped inclusion defects

Several different kinds of bubble-shaped defects were observed in the steel samples, such as shown in Table 1 (S6) and in Table 4. These defects contain a ring of inclusions around the former boundary of the bubble, or in its wake. Their composition varies widely, but always include inclusions of pure sulfides (MnS) and usually also compound Al₂O₃-MgO inclusions. Although the individual inclusions are small, the entire defect is dangerously large, with diameter of 50-300µm. These defects are believed to arise through the following mechanism:

- Step 1: A moving bubble collides with inclusions which attach to most of its surface;
- Step 2: Inclusions form a shell around most of the bubble surface;
- Step 3: The gas bubble escapes (argon or CO) or reacts / absorbs in the steel (air bubbles);
- Step 4: The shell of inclusions is filled in with molten steel;
- Step 5: Sulfides precipitate during solidification.

MnS	Sulfide (likely precipitated onto former bubble surface during solidification)
S30

MnS	Sulfide (likely precipitated onto former bubble surface during solidification)
S31

1	Al ₂ O ₃ 90.76 FeO 9.24	Alumina aluster (from reoxidation) and sulfide inclusions around the surface of a bubble-like cap (air)
		2	MnS 100	
S32

1	SiO ₂ 21.84 MnO 1.00 FeO 77.16	Mold flux, reoxidation Inclusions around the boundary of a bubble-cap (Sulfide)
		2	MgO 15.52 SiO ₂ 0.60 MnS 15.42 CaO 1.51 MnO 18.75 FeO 48.20	
		3	MnS 100

1	Al_2O_3 78.17 MgO 11.61 FeO 10.22	Inclusion cluster (alumina from reoxidation plus ladle lining) at the boundary of a former air bubble
		2	Al_2O_3 76.23 MgO 15.61 FeO 8.16	
S34

1	Al_2O_3 83.32 MgO 16.68	Inclusion cluster (alumina from reoxidation plus runner, trumpet or ladle bottom lining) attached to the boundary of a former air bubble
		2	Al_2O_3 83.88 MgO 5.97 CaO 7.29 FeO 2.85	
S35

1	Al_2O_3 84.05 MgO 15.95	Compound inclusion (alumina from reoxidation and ladle lining) along boundary of a former air bubble Sulfide
		2	MnS

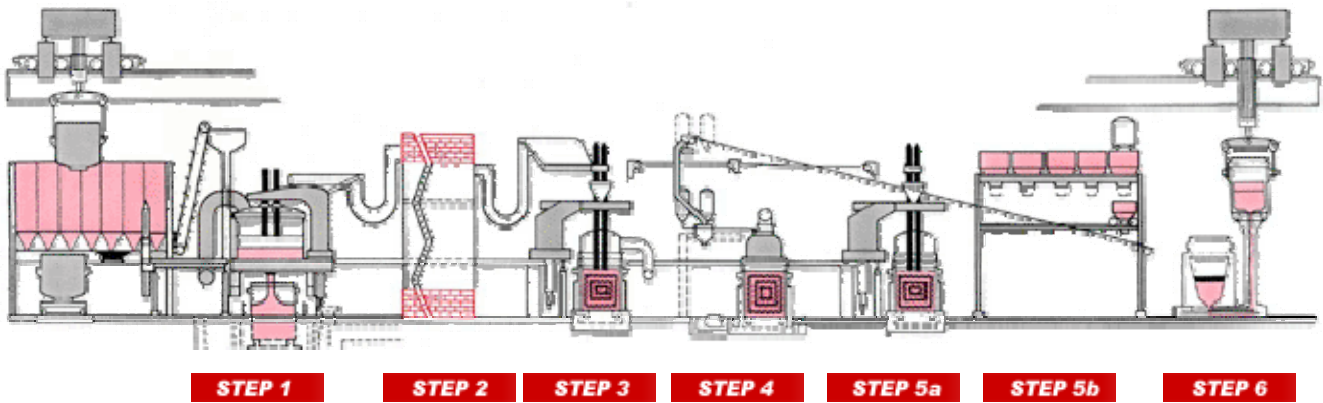
Fig.1. Schematic of ingot production process

The ingot casting process of concern is shown figure 1 and is described as follows:

- Step1: Scrap is loaded into clam-shell buckets and charged into an ultra high powered (UHP) eccentric bottom tapping furnace (EBT) electric arc furnace. The scrap is melted and refined to remove carbon and phosphorus using an oxidizing slag.

- Step2: The EBT feature minimizes heat loss and allows the liquid steel to be tapped relatively slag-free into the ladle for further refining. During tapping, alloy additions are charged, including aluminum for deoxidation, followed by the addition of a reducing top slag.

- Step3: The ladle is transferred to a treatment station for heating, alloy adjustment and further refining. Arc heating and induction stirring at this step ensures mixing and interaction between the steel and the slag.

- Step4: The steel bath undergoes vacuum degassing where the hydrogen level is lowered to less than 1ppm. Induction and argon gas stirring are combined during this step to optimize stirring energy.

- Step5: The ladle is transferred to a second treatment station, where the steel may be reheated, calcium treated via wire feeding. Final alloy adjustments are made as needed.

- Step6: Heats are bottom teemed into ingots at a designated temperature and a controlled rate of rise. Argon shrouding may be employed prior to teeming to minimize reoxidation and the pick-up of hydrogen and nitrogen. Argon shrouding was not used on the test ingots of this study, however.

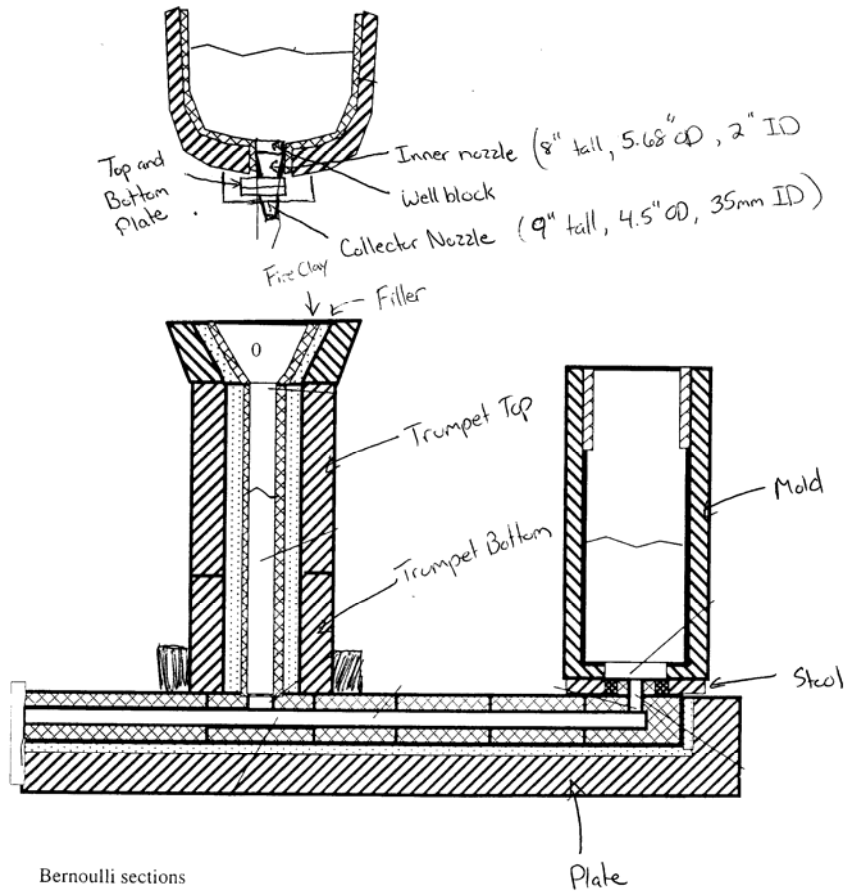
Fig.2 Schematic of bottom teeming process

The ingots in this study were round with 0.33m diameter, 4.70m height and 2.91 metric tonnes in weight. The total filling rate was around 1.4 tonne/min (23kg/s), with 3.3kg/s to each ingot. This increased the ingot level at 4.87mm/s. The typical filling time was 13-18 minutes, Mold powder was added by placing a 5-kg bag on the bottom of each ingot prior to teeming. Some operations suspend the bags of powder above the bottom to lessen powder entrapment during the start of filling??. Important topics of interest include the filling rate (rate of rise), the delivery-system geometry, which may cause turbulence and encourage mold powder entrapment, slag entrapment by vortexing near the ladle nozzle at the end of teeming, argon shrouding, and the erosion of refractories.

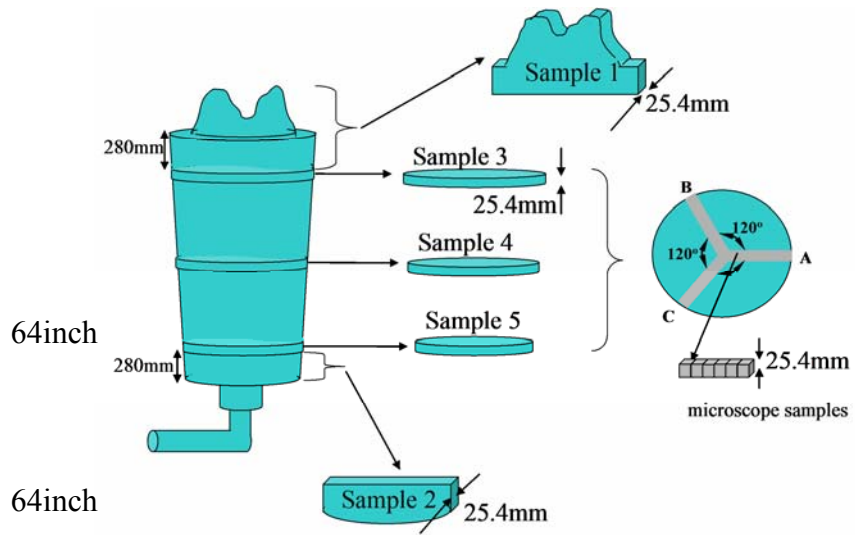
Fig.3 Schematic of sampling locations in 13inch round ingot (A is away from the trumpet)

After final solidification, the ingot was sectioned. Figure 3 diagrams how the samples were obtained, where “A” indicates the direction away from runner from the trumpet. In total, 54 cube-shaped steel samples of 25.4mm (1inch) per side were examined for inclusions. The total observation area was almost 35,000mm². In addition, the solidified runner bar/spider for this ingot was also examined. After polishing, the samples were first observed under an optical microscope to mark the locations of all inclusions larger than 20µm in diameter. Then, the detailed morphology and composition of each inclusion was analyzed by scanning electron microscope (SEM) using Energy

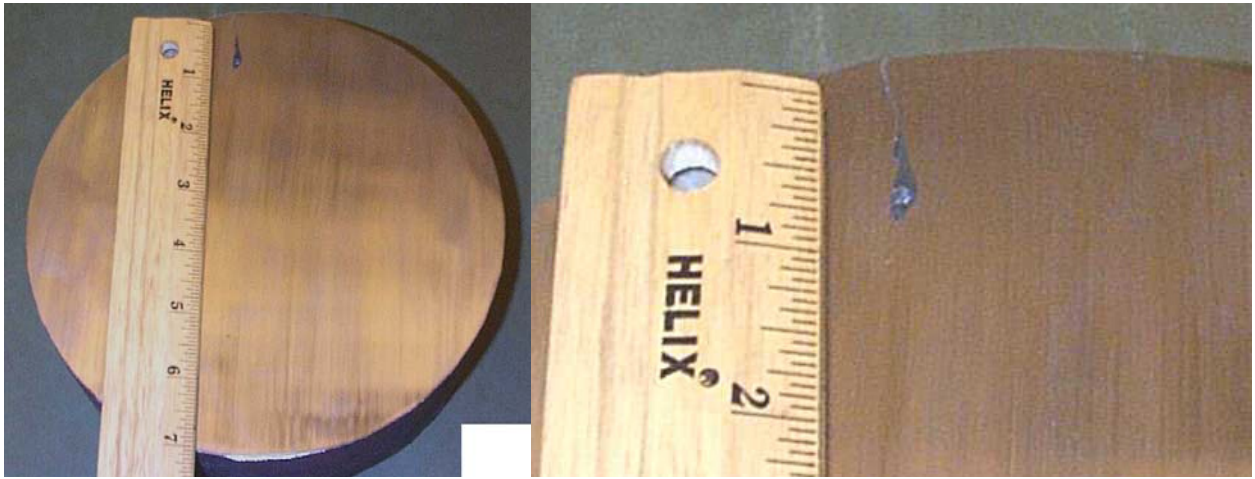
Fig.4 Large nonmetallic inclusions found in the forged ingot

In the forged bar samples detected by Submerged Ultra Sonic Scanning, only two inclusions were detected. As shown in Figure 4, one of these macro-size nonmetallic inclusions was uncovered at the top end of the bottom bar while trimming the end. This huge defect exceeded 20mm in length, even after forging. It contained O, Na, Mg, Al, Si, K, Mn, S, and Ca, indicating it to originate from mold flux. The fact that so few exogenous inclusions were found by Ultra Sonic Detection indicates that this method can reveal only large inclusions, exceeding ~ 1 mm in diameter. It is crucial to detect such large and rare inclusions. However, determining the true cleanliness of the steel also requires microscope observation and SEM detection.

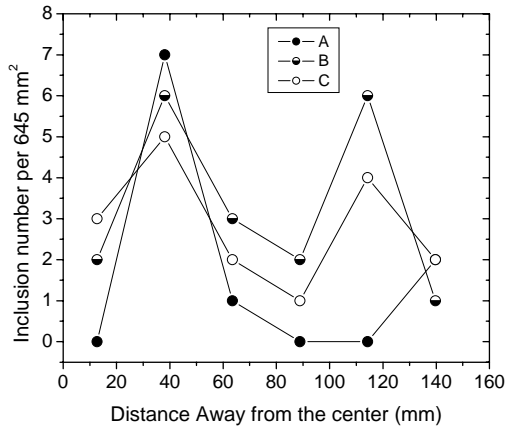
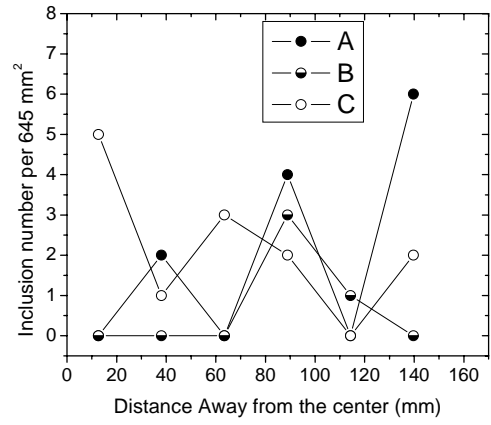
Fig.5 Inclusions (>20 μ m) observed at 280mm from bottom (left) and half height (2350mm from the bottom) (right) of the ingot

The total of 78 non-sulfide inclusions larger than $20\mu\text{m}$ that were detected in the ingot are plotted in Figures 5 & 6 according to their location along each bar-sample. In the 11613 mm^2 total area observed at each of three ingot heights, most (47) of these large inclusions were observed on the section near the ingot bottom (sample 5), 29 on the half-height samples, and no inclusions were found on the ingot upper section. Thus, the most important trend in entrapment location is a decrease in inclusions with height up the ingot. At the ingot bottom, inclusions appear to concentrate in two regions, peaking at 40mm from the center line and at 20mm from the surface. At the ingot half height, inclusions are distributed more randomly, although there may be a slight concentration at the ingot surface. At every height, inclusions are randomly distributed around the ingot perimeter, but there may be a slight trend of more inclusions towards the trumpet side of the ingot near the ingot bottom.

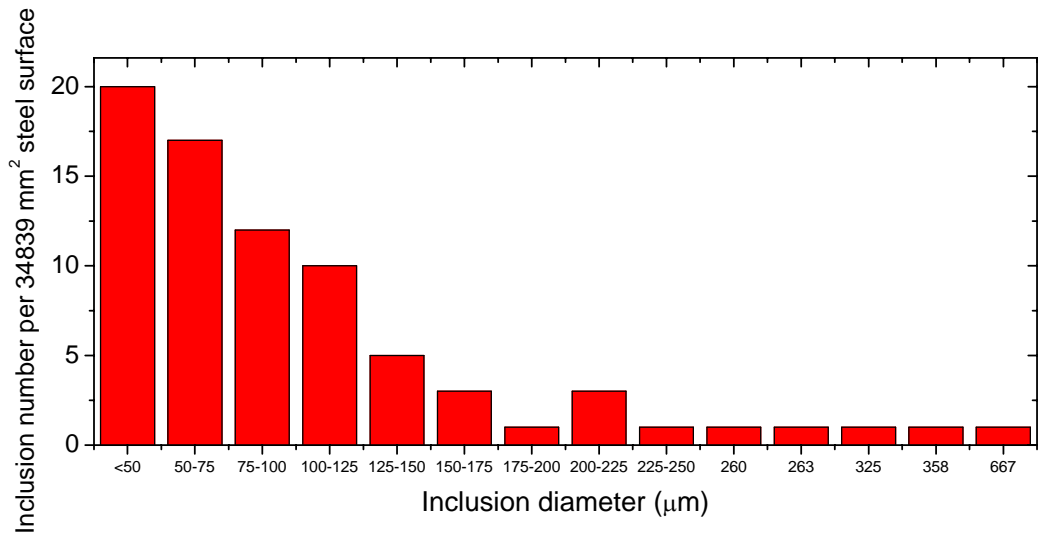
Fig.7 Two-dimensional size distribution of inclusions by microscope observation

The inclusion size distribution from the two-dimensional microscope observations is shown in figure 7, and was converted into the three-dimensional size distribution in figure 8, using Eq.(1).

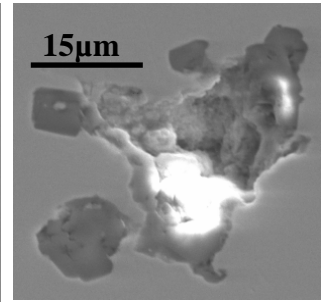
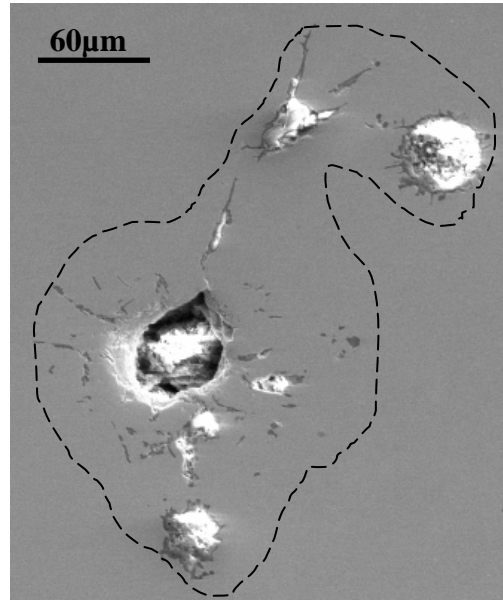
Fig.9 Morphology of pure alumina clusters

Typical clusters of pure alumina inclusions are shown as S1 and S2 in Table 3 and in figure 9. Of the 78 total non-sulfide inclusions observed in the ingot, the majority (46) were pure alumina, which were almost all larger than $50\mu\text{m}$. Roughly half (25) of these were alumina clusters, while the others were irregular-shaped lumps of alumina. The clusters range from being partially surrounded by steel, as shown in S7 and S10, to being relatively exposed, as shown in S9. Some clusters even had steel trapped inside them, such as S8. Some alumina clusters were caught together in the liquid steel, as shown in S11. The center of S11 was dislodged during polishing and became dirty inside. The individual particles in the alumina clusters range from $1\text{-}5\mu\text{m}$ in diameter.

Possible sources of alumina clusters include deoxidation products, reoxidation by air absorption, Ostwald-Ripening of dendritic alumina, and sintering together (by collision) of many small alumina inclusions. Their composition was measured to be almost pure alumina, so they could not arise from refractory brick or slag. The clustering of deoxidation products is a possible source, but the strong refining practice should have prevented such large quantities with such high purity. The most likely source, at least of the large clusters, is air reoxidation. No perfect dendritic alumina inclusions were observed, which suggests that significant time has passed since original formation of the dendritic alumina in a high-oxygen environment. Air absorption likely took place between the ladle and the trumpet during teeming, or at the top surface of the molten steel in the ingot during filling. During the teeming process of this trial, there was no protection where the ladle drains into the trumpet, so air absorption is likely very severe at that location.

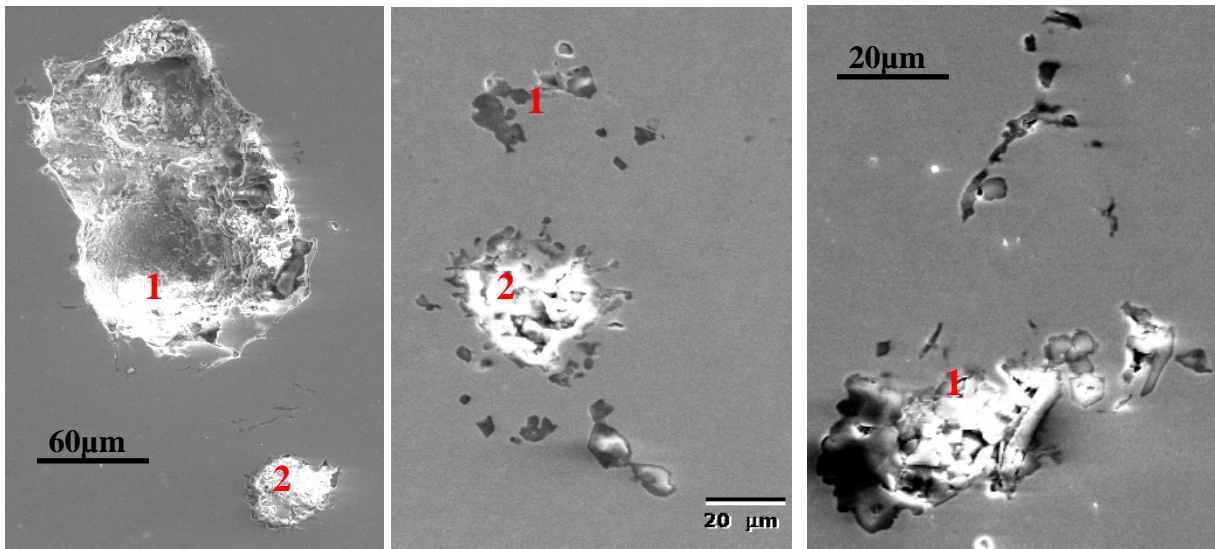
Fig.11 Alumina clusters with exogenous inclusions

Several multi-component clusters that contained alumina and other exogenous inclusions were observed, as shown in Figure 11. These inclusions likely have a multi-stage formation mechanism. Their complicated composition suggests that alumina particles combined with mold flux, broken lining refractory, and / or ladle slag. Micrograph S17 shows a $\sim 250\mu\text{m}$ irregular cavity with some inclusions remaining inside, which means that most of the inclusion was polished away. The composition at

location 1 is Al₂O₃ 69.94%, MgO 15.84%, FeO 4.79%, K₂O 7.32%, Na₂O 0.76%, ZrO₂ 1.37%, which suggests that this inclusion was from mold flux. The inclusion at location 2 is a pure alumina cluster, larger than 50µm. When large exogenous inclusions move through the liquid steel, they may grow by nucleating other compounds from the supersaturated molten steel, or by simply colliding with other inclusions. Inclusions S18 and S19 are examples of a large alumina cluster capturing exogenous inclusions from the lining refractory (Al₂O₃ 84.41%, MgO 5.77%, FeO 2.96%, CaO 2.57%). Inclusion S19 is comprised of Al₂O₃ 76.71%, MgO 23.29%, and is a compound inclusion cluster.

Many (17) large inclusions of Al₂O₃-MgO were found, such as shown in S18, S19 in Fig.11, and S20, S21 in figure 12. Their compositions are similar to ladle well block, and their shape is irregular with 20-30 µm size. These inclusions may have formed by erosion of the ladle well block, or by alumina clusters firstly attaching to the surface of the well block as a clog, later becoming dislodged into the liquid steel, perhaps reacting with well block material, and finally being captured by the solidified shell. .

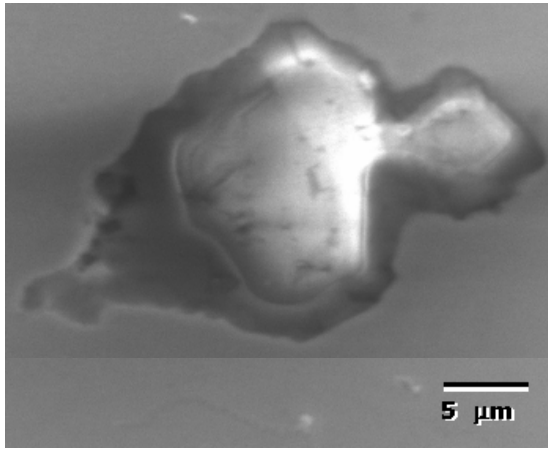
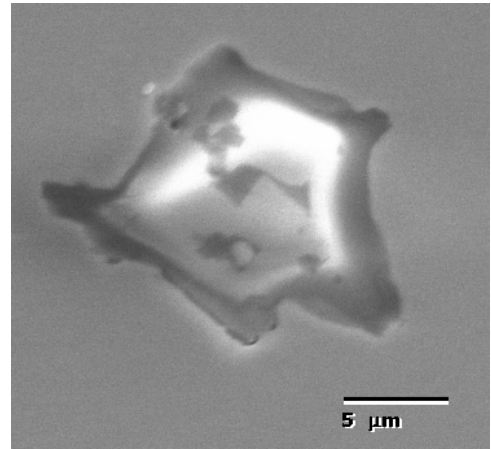
Fig.12 Al_2O_3 -MgO inclusions

S20 (Al_2O_3 71.72, MgO 23.56, FeO 1.82, MnO 2.90)

S21 (Al_2O_3 89.26, MgO 10.74)

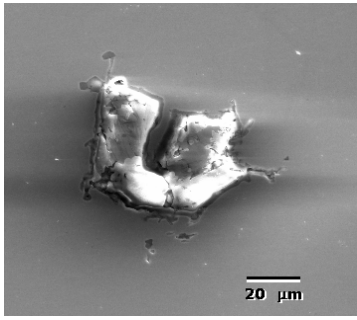
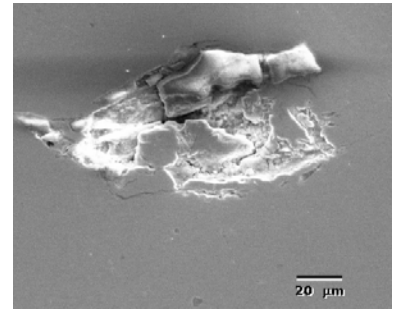
Fig.13 Exogenous inclusions from ladle inner nozzle

Seven inclusions were found to contain Al₂O₃ 94-98%, ZrO₂ 2-6%, which is very similar to the composition of the ladle inner nozzle. The ladle inner nozzle (Al₂O₃ 94.00%, ZrO₂ 2.50, SiO₂ 1.00%, others 2.50%) is the only lining refractory that contains zirconium oxide. Thus, during the teeming process, it appears that the ladle inner nozzle was eroded and dislodged inclusions into the liquid steel, likely due to excessive fluid velocity, high temperature and / or long time. These inclusions are shown in Figure 13. Inclusions S24 and S25 have been partially pulled out during polishing process.

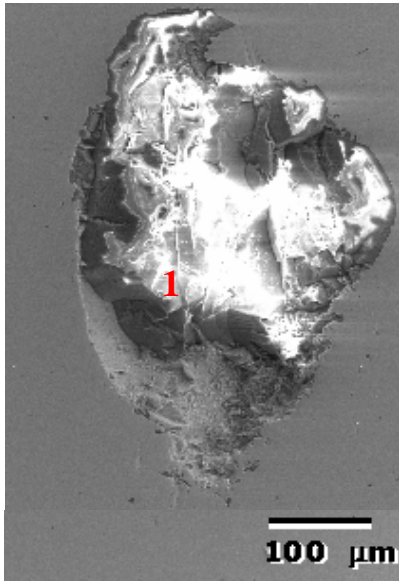
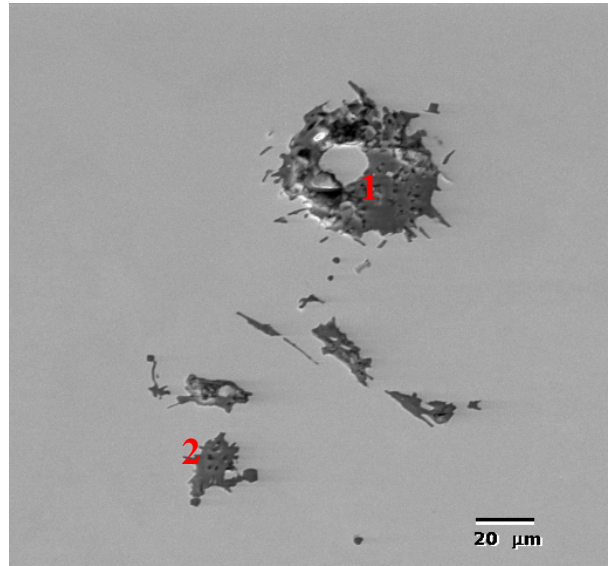
Fig.14 Inclusions from mold flux and runner brick

Six inclusions were observed that contained high K₂O or Na₂O composition. These inclusions are likely from entrapped mold flux, (S26), or perhaps from broken runner brick, (S27), as shown in figure 14. Some of these inclusions are very large, exceeding 150-600µm.

Al₂O₃ 22.05%, SiO₂ 47.02%, MgO 1.88%, CaO 3.15%, FeO 8.51%, MnO 11.95%, K₂O 1.52%, Na₂O 5.07%

1: Al₂O₃ 83.22, MgO 4.36, K₂O 10.26 CaO 2.16
 2: Al₂O₃ 81.05, MgO 3.62, K₂O 10.27, CaO 1.04, FeO 4.03

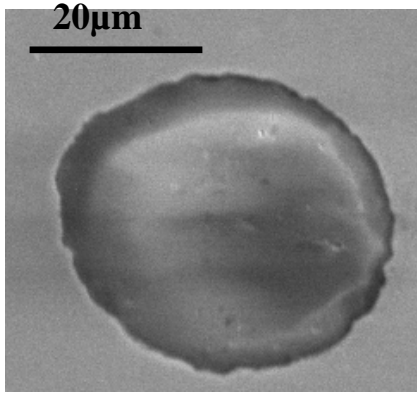
Fig.15 Silica based inclusions

Two spherical silica-based inclusions larger than 20µm were observed. An example is shown in figure 15, with composition Al₂O₃ 61.23%, SiO₂ 2.83%, CaO 35.94%. These inclusions may have originated from ladle slag. They are not mold flux because there is no K₂O and Na₂O.

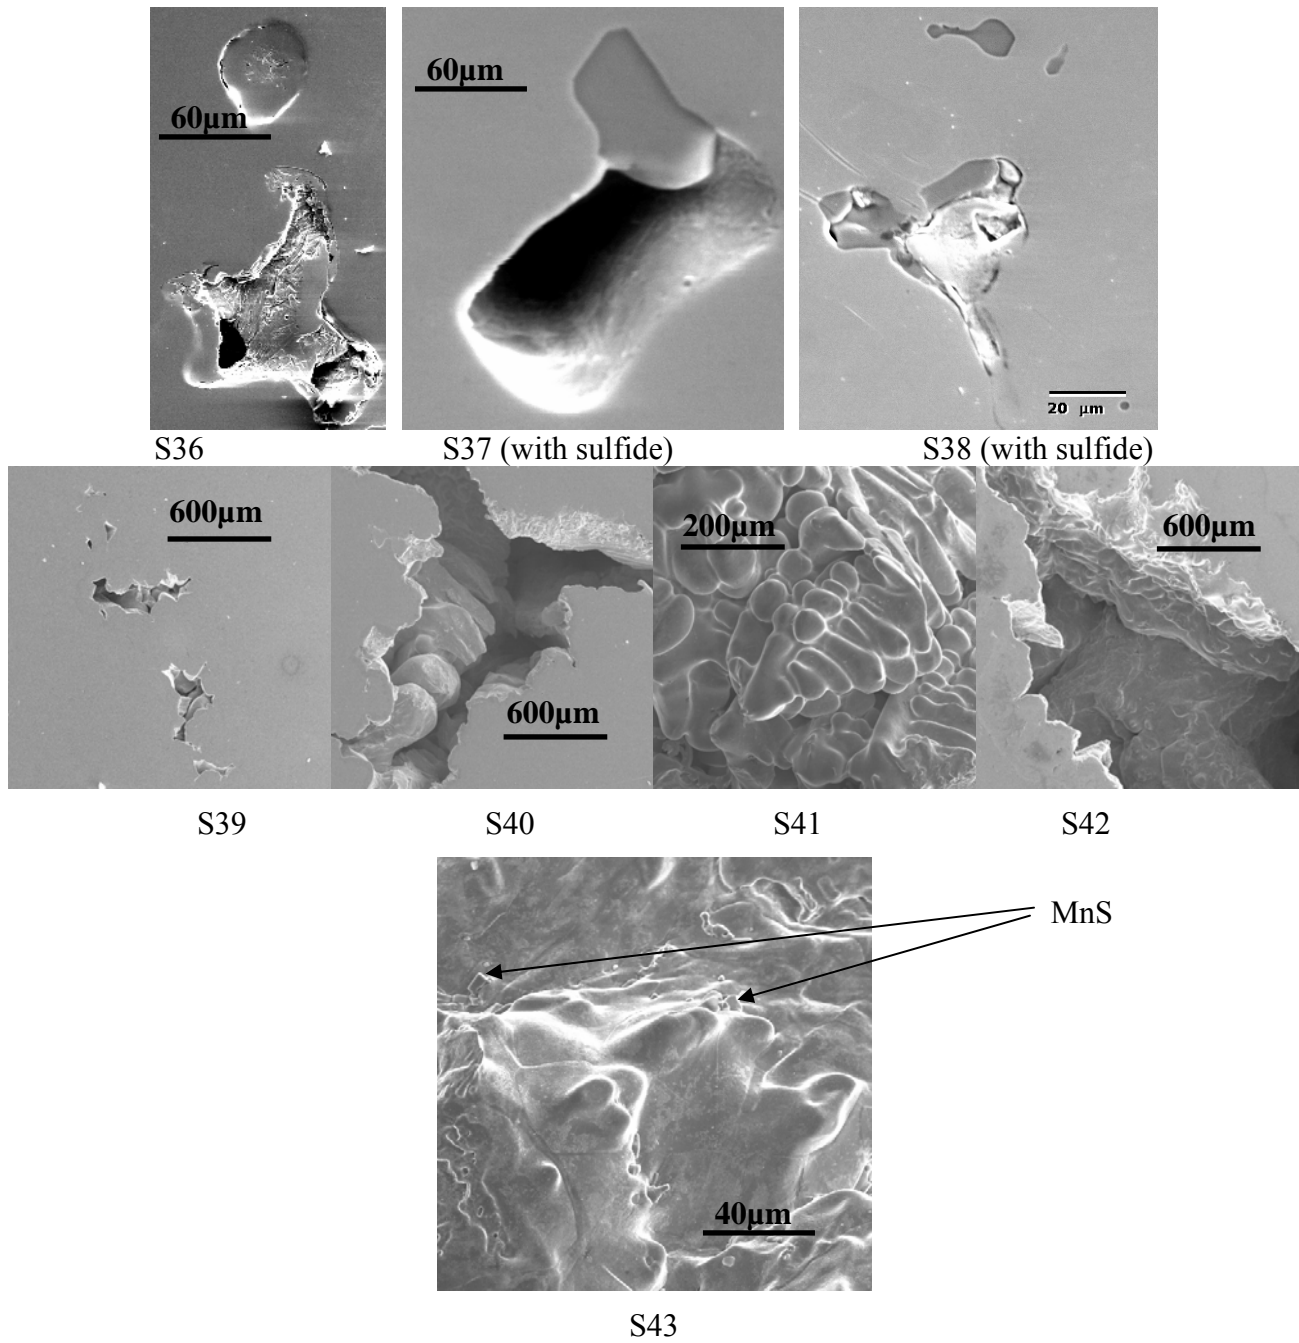
Fig.16 Cavity and holes found on the steel samples

Many different types of cavities and holes were found in the samples. Some of these simply arose during polishing by dislodging inclusions, such as shown in Table 1 (S1, S4), Fig.9 (S11), Fig.11 (S17), Fig.13 (S24 and S25). Spherical bubble-shaped holes were likely created during solidification by the escape of gas bubbles (N₂ bubble, CO bubble, and possible argon bubble), such as shown in S29 and S30 in Table 6. Irregular-shaped holes were created during the final stages of solidification comprise interdendritic cavities called “micro-porosity”. Examples are shown in S5 in Table 1, S36-42 in Table 5, and in Figure 16.

The cavities from micro-porosity form due to liquid feeding problems into the interdendritic spaces, so were more often observed near the ingot center where the mushy zone is larger and liquid feeding is more difficult. They are often associated with sulfides, which concentrate in the same region due to microsegregation of S and Mn. Fig.16 shows several interesting examples. Sulfides are present along the dendrite boundaries (holes) in S37 and S38. The void cluster in S39 illustrates mild microporosity. Closeups of severe microporosity near the ingot centerline, shown in S40 and S42, show the jagged nature of the interior of voids. The void edges are the surfaces of dendrites, as revealed in S41, complete with classic secondary arms. A closeup of the dendrite surface in S43 shows MnS inclusions on the dendrite edges, which are likely the precipitated remnants of an interdendritic liquid film.

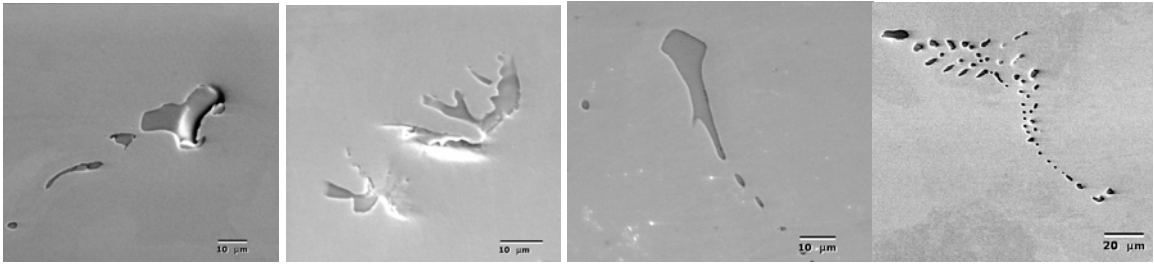
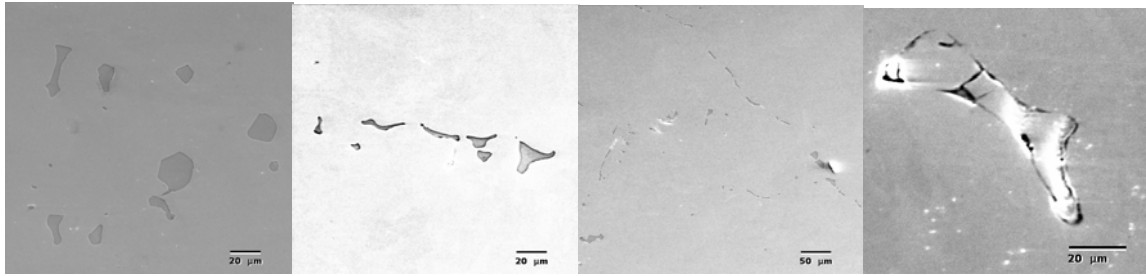
Fig.17 Sulfide inclusions

A great number of pure sulfide (MnS) inclusions were found in the steel samples. A few examples, are shown in S6 in Table 1, S29,30,31,32,35 in Table 4, S37, 38 and 43 in Fig.16, and in figure 17. These inclusions often appear in clusters with a large size (exceeding >100μm) and are generally much greater than the individual inclusions. Sulfides tend to concentrate around the boundaries of former bubbles and near interdendritic cavities (S6 in Table 1, S29, 30, 31, 32, 35 in Table 4, S37, 38, 43 in Table 5).

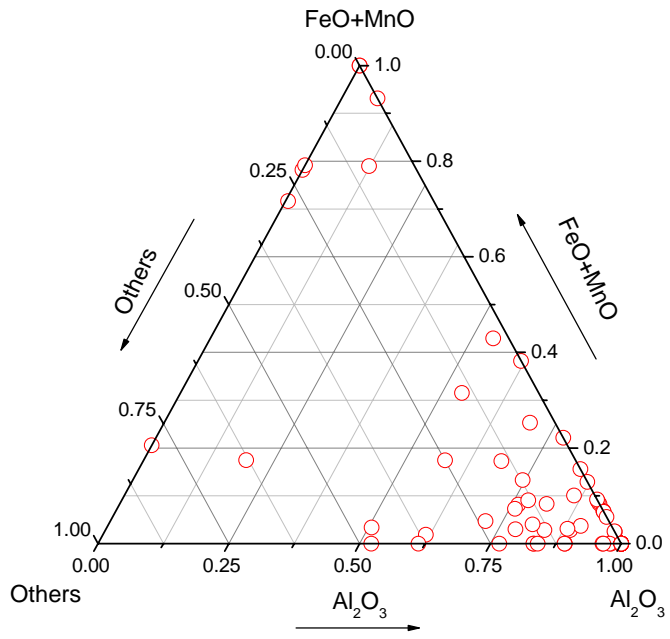
Fig.18 Composition of non-sulfide inclusions observed in the samples

The compositions of all 78 of the observed non-sulfide inclusions are plotted on the ternary phase diagram in Figure 18. In total, 59% of the large inclusions (>20μm) were pure alumina or alumina/FeO inclusions. These inclusions are believed to arise mainly from air reoxidation. The most likely places for air absorption are the connection between ladle and trumpet during teeming, and the top surface of the molten steel in the ingot during filling. Of the remaining inclusions having complex composition, 22% were from ladle well block refractory, 9% from the ladle inner nozzle, 8% from mold flux, and 2% from slag inclusions (not mold flux), as shown in Table 5. No inclusions from runner or trumpet brick were found. Mold flux inclusions are more important than indicated here, because the two huge inclusions detected by ultra-sonic detection are not included. In addition, a much larger number of pure sulfide inclusions and smaller inclusions of all types were also observed.

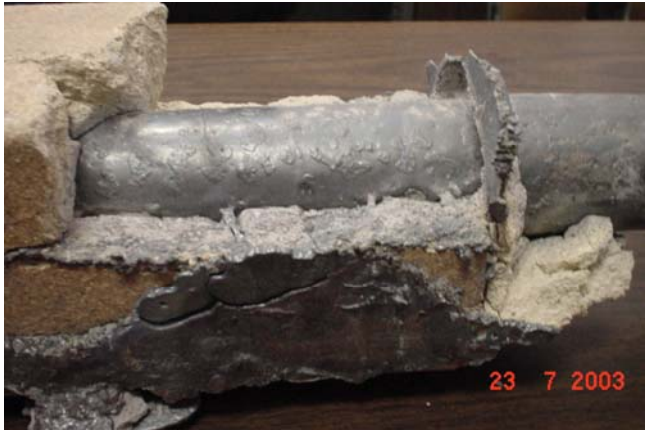
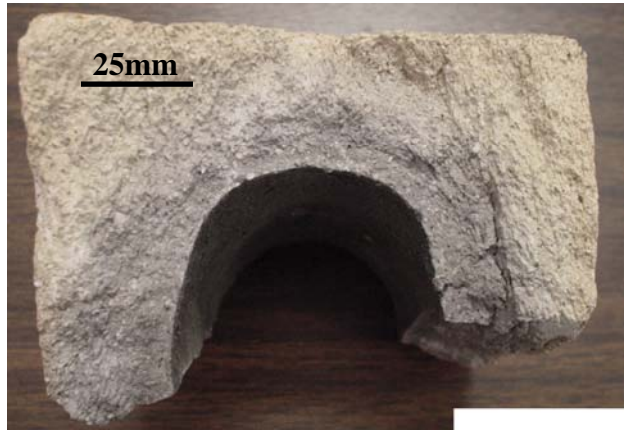
Fig.19 Used Runner Brick

The used runner bricks, shown in figure 19, were also investigated. A layer of black slag-like material was observed between the runner steel and the surrounding refractory brick that partly adhered to both surfaces. The shape of the steel in the round runners was flattened across the top, presumably due to the combined effects of solidification shrinkage and gravity. The slag layer built up more in this top region of the runner, where it averages ~3mm thick and was 0.3mm thick at the bottom (figure 20). Evidence of the molten steel breaking through cracks in the runner brick and leaking around the bricks is observed as large attached fins in several places (Fig.19). The black slag layer contains gas porosity. Analysis using SEM detection shows that three layers exist in the used brick near the steel: original brick, intermediate layer and reaction layer (runner slag) (Fig.20). The

The above findings explain how runner slag forms from air absorption and interaction between high-Mn molten steel and runner bricks that contain SiO₂. To avoid the quality problems that likely result from this runner slag, it is recommended that SiO₂ in all of the refractories be avoided, by increasing the Al₂O₃ content up to 60%, or by using ZrO₂-based refractories. A comprehensive refractory-lining specification is essential for the production of high quality forging ingots. Consistent acceptable composition, porosity, bulk density and strength of the bricks should be maintained, in order to control inclusion content of the final product.

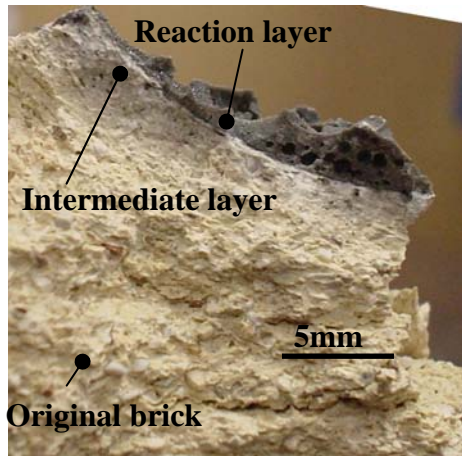
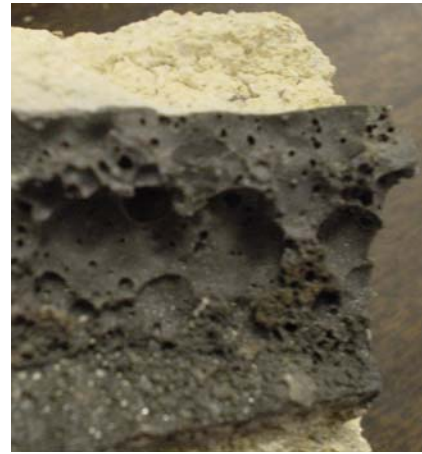
Fig.20 Runner slag

composition of three layers is shown in Table 6. From the original brick to the reaction layer, the SiO₂ concentration decreases, while the levels of other oxides, including Al₂O₃ and MnO generally increase.

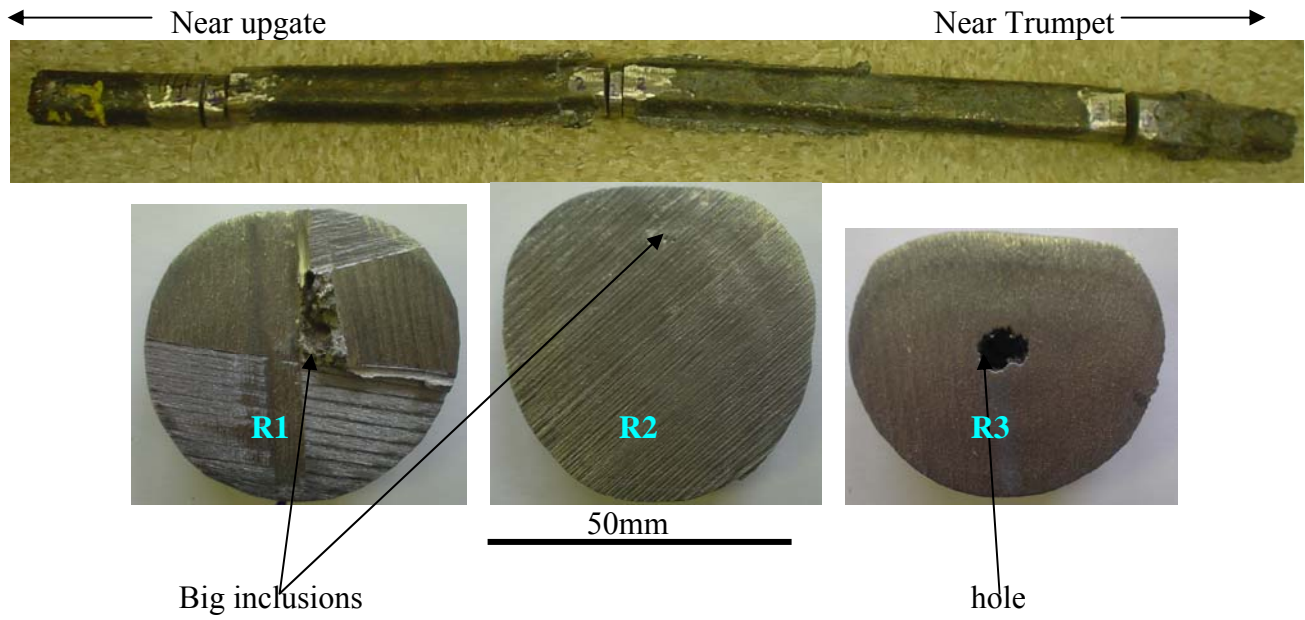
Fig.21 Runner steel samples (near upgate, runner midpoint, and near trumpet from left to right)

Samples of steel in the runners were taken near the upgate (sample R1), half-way along the runner (sample R2), and near the trumpet (sample R3), as shown in figure 21. The runner steel samples were cut into 4 quadrants and observed under optical microscope for inclusions larger than 20µm, which were further analyzed by SEM.

Large central inclusions: Extremely huge inclusions (near upgate, runner midpoint) and large voids (near trumpet) were observed in the center of many of the runner samples. These inclusions exceeded 7mm in size, such as shown in Fig. 21. The morphology and composition of these big inclusions are shown in figure 22. The matrix of the large inclusions contains ~18%Al₂O₃, ~40%SiO₂, ~40%MnO (surface average). Different spots have slightly different compositions. There are many needle-shaped inclusions of pure Al₂O₃, (light crystalline phase) which are around 5-10µm in diameter, and 10-100µm in length. These pure Al₂O₃ needles likely crystallized inside the large central inclusions while they were still liquid. These inclusions are entrained runner slag.

Slag inclusions remain in a liquid state while the steel solidifies. Thus, they can be pushed by the growing dendrite tips, to coagulate and collect at the last place to freeze near the runner center, where macroporosity (voids) are also common. The closeup views of the inclusion boundaries in Fig. 22 clearly show that slag filled in the interdendritic porosity. This filling was incomplete, as indicated by the interdendritic porosity remaining in Figure 23. This figure clearly reveals the dendritic tip shape around the interior of the void.

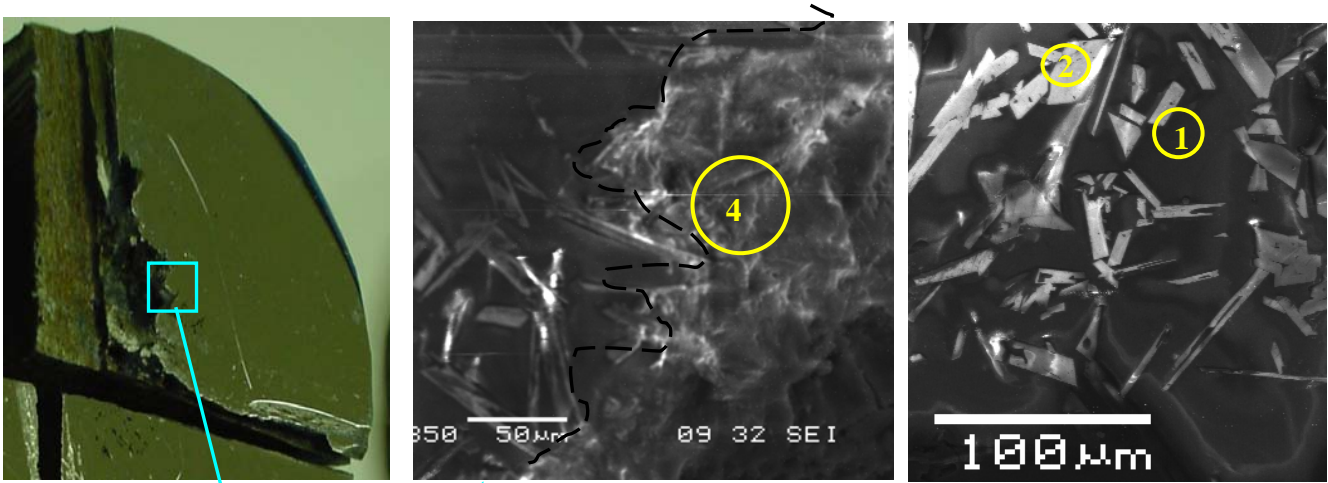
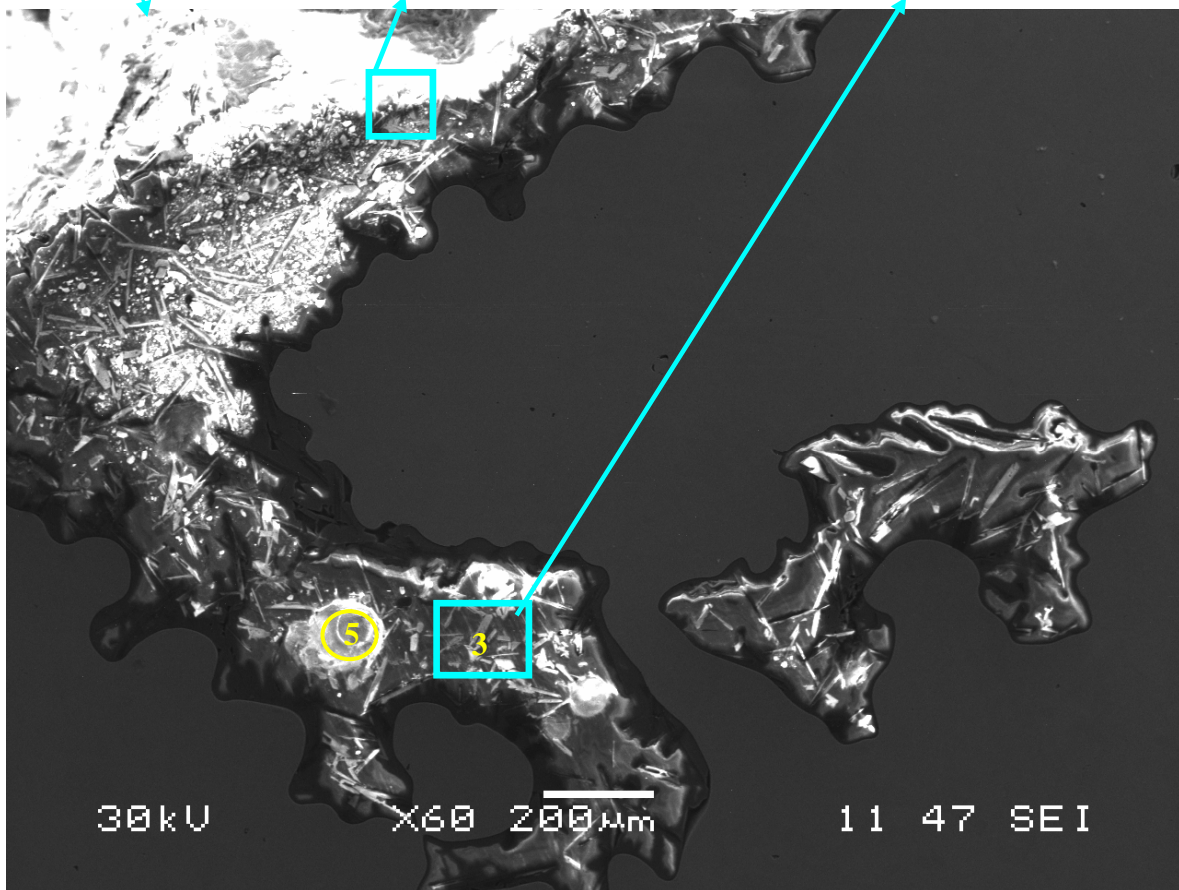
Fig.22 MnO-rich inclusions at the center of runner steel samples

Although they were found in many runner samples, inclusions rich in MnO were rarely found in the ingot. This suggests that these inclusions require long times for reactions to occur, such as between the liquid steel and the refractories. Thus, they likely form later during teeming, and are more likely to remain in the runner.

Al ₂ O ₃	SiO ₂	MnO	K ₂ O	Na ₂ O	TiO ₂
1	19.93	40.02	36.23	1.23		2.57
2	100					
3	47.16	32.75	20.09			
4	7.12	78.39	11.21		1.94	
5	3.88	82.4	10.20	1.23	1.39

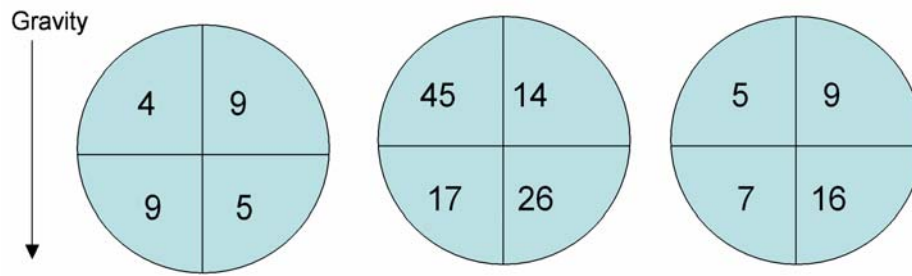
Fig.25 Inclusion distribution on runner steel samples

The number of inclusions observed in each quadrant is included in figure 25. The inclusions generally show a random distribution between quadrants of the samples near the runner ends, where the flow conditions are complicated. In the mid-length sample, more inclusions are found in the upper half of the runner. This is likely due to the the stable fully-developed pipe flow conditions allowing the lower-density inclusions to drift upwards and redistribute at this location.³³⁻³⁵
