# 3D THICKNESS MEASUREMENT TECHNIQUE FOR CONTINUOUS CASTING BREAKOUT SHELLS

The shell thicknesses following a breakout have been accurately measured using a laser scanner and the variations in shell thickness were related to mould thermal monitoring data.

(DSP) are discussed. The first breakout is related to entrapment of a large inclusion on the wide face. The second is a narrow face breakout related to localised shell thinning and incorrect taper settings.

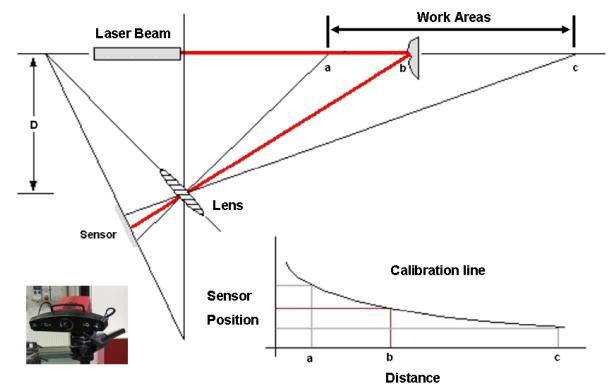
Figure 1. The principle of triangulation

ATOS is a flexible optical measuring machine based on the principle of triangulation (*Figure 1*) projected fringe patterns are observed with two cameras. 3D coordinates for each camera pixel are calculated with high precision, a polygon mesh of the object's surface is generated [1].

*The principle of triangulation:* The distance between the laser source and sensor is known. The laser shoots light at the object being measured and this is reflected back to the sensor via the lens. Point b can be calculated from knowing a, c and distance D.

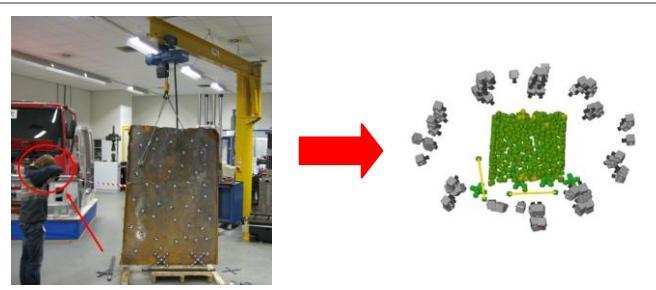
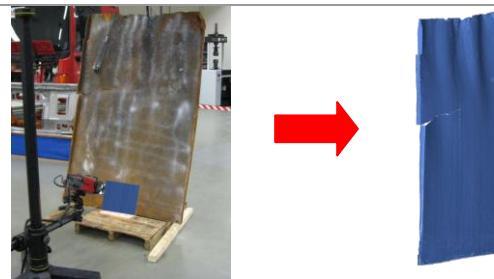
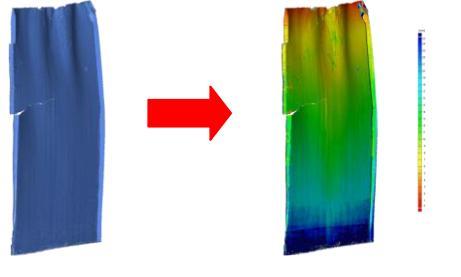
Figure 2. The measuring procedure in three steps

TRITOP is an optical coordinate measuring machine. This mobile technology is designed to define the exact 3D position of markers (telemetry). TRITOP is used to identify the reference markers on both sides of the shell to support the ATOS measurements. When both sides of the shell are in the same coordinate system, a 3D thickness calculation is possible [1]. *Figure 2* shows a short illustration of the measuring procedure in three steps.

Step 1. The TRITOP system is measuring the exact position of the reference markers on both sides of the shell.

Step 2: After scanning the individual areas on the shell (both sides) with ATOS, the TRITOP is combining these areas into one single surface.

Step 3: From a single 3D surface to thickness calculation.

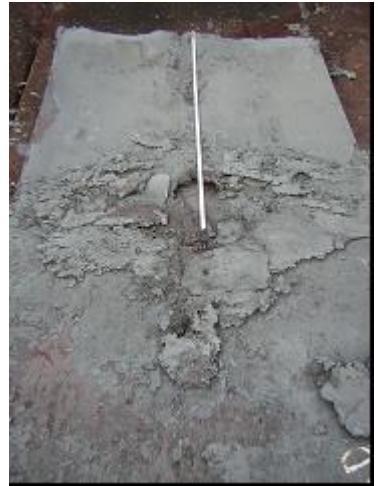
Figure 3. Breakout shell (loose side)

*Figure 3* shows a photo of the breakout shell used for further analysis.

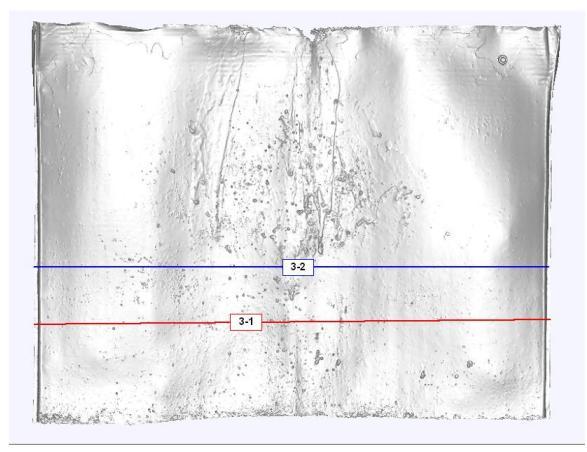
Figure 4. The half-breakout shell under study. Lines blue and red are used for the thickness-plane measurements.

Due to the breakout hole and some splashes attached to this breakout side of the shell, the opposite side of the breakout was used in the laser measurement. Therefore, the full fixed face side and half of both narrow sides were used for the measurement. *Figure 4* shows the half-breakout shell under study.

To be able to clarify the reduction in thickness, two positions were used to measure the shell thickness along a line (lines in red and blue in *Figure 4*).

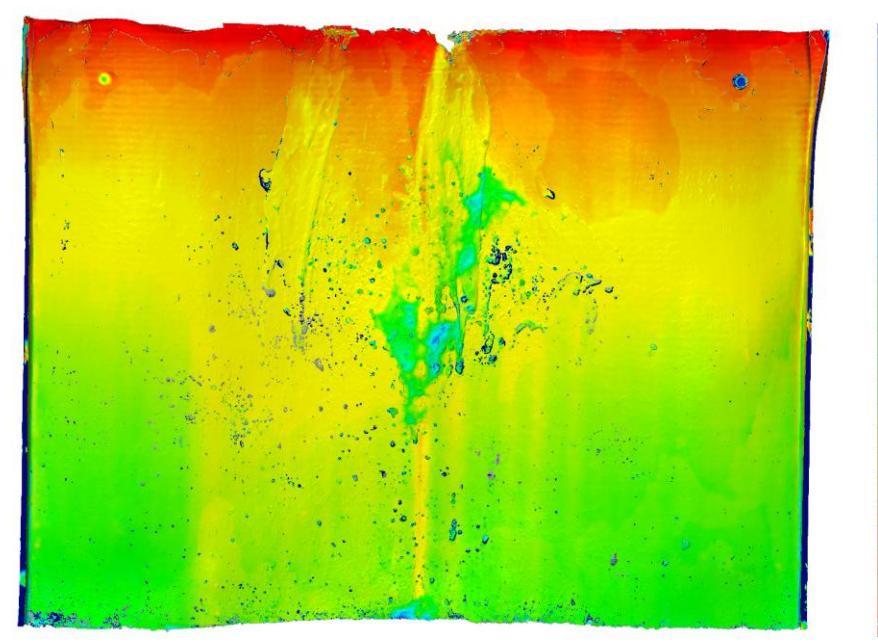
Figure 5. A 3D view of the shell thickness.

A 3D view of the shell thickness is shown in *Figure 5*. In this image it is noticeable that the breakout shell has no constant thickness and displays three kinds of thinning:

- local thinning in the longitudinal direction
- local thinning in the vertical direction
- thinning in areas of the shell

The localised reduction in the thickness is about 50%, compared with other areas; especially in the longitudinal direction.

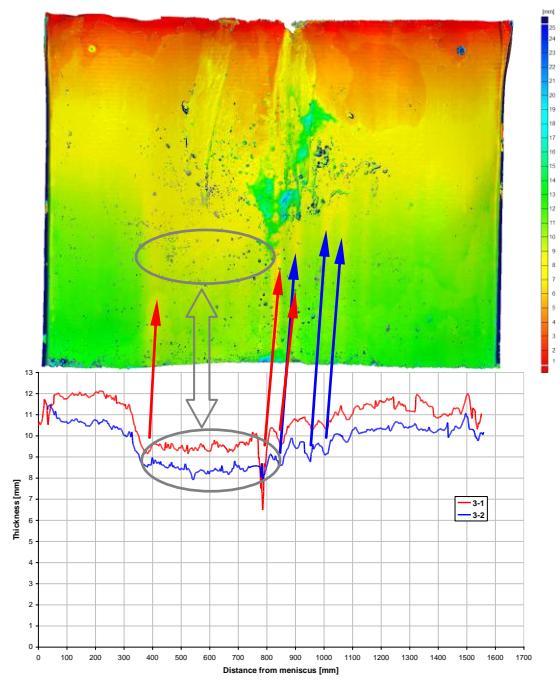
Figure 6. Results of the line measurements compared with the 3D view.

Results of these positions compared with the 3D view are shown in *Figure 6*.

The lines show more clearly the reductions in thickness of the shell, indicating the localised and areal thinnings.

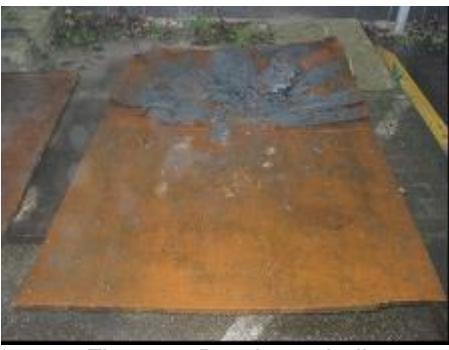
Figure 7. Breakout shell.

Consequently, after the breakout event, the breakout shell was put aside for further analysis, and the breakout shell was studied and its thickness measured with the 3D laser technique. *Figure 7* shows a photo of the breakout shell.

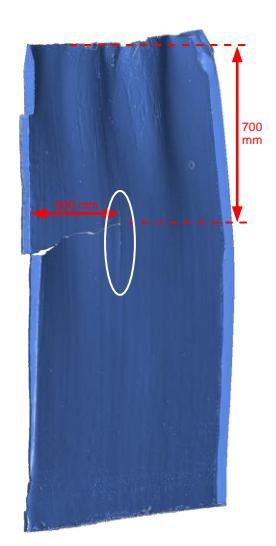
Figure 8. Half-breakout shell under study. Into the white oval the LFC is shown.

Part 1: The full east wide face (fixed side) and half of both narrow sides were used for the measurement. *Figure 8* shows the half-breakout shell under study. In the middle of this half-shell a longitudinal crack was found (circled in white). In red the distances of the crack to meniscus and from the south narrow face are shown.

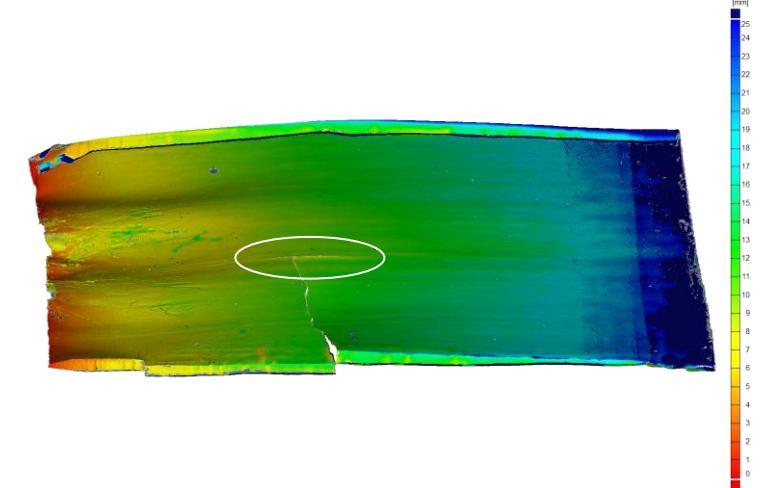
Figure 9. A 3D view of the shell thickness.

A 3D view of the shell thickness is shown in *Figure 9*. In this image it is noticeable that the breakout shell has no constant thickness and again displays the same three kinds of thinning as in breakout A: - local thinning in the longitudinal direction

The localised reduction in thickness is also about 50%, compared with other areas; especially in the longitudinal direction (longitudinal crack).

In figures *Figure 9* and *Figure 10*, the longitudinal crack is marked with a white oval. The transverse crack in this breakout occurred during the extraction of the breakout shell from the machine because the extraction of the shell was done from the top of the mould; however it obviously had a transverse local thinning of the shell in the corner region to initiate this cracks (thinning marked in *Figure 11*, blue line).

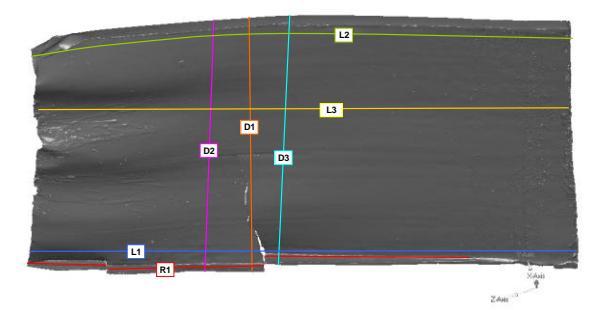
Figure 10. Schematic representation of the sections for thickness measurement.

Two sets of positions were chosen in part of the breakout, three in the transverse direction and three in the longitudinal direction. In *Figure 10* a schematic view of the line's positions is shown.

- R1 (red line): longitudinal plane in the narrow face (south), about 15 mm from the corner.

- L1(blue line) and L2 (green line): also longitudinal sections, approximately at 15 mm from the corner, L1 close to the south narrow face and L2 close to north narrow face.

- L3 (dark yellow line): Longitudinal section to compare the thickness of the shell between the middle and the sides of the slab.

- D1 (orange line): in the middle of the longitudinal crack

- D2 (pink line) and D3 (turquoise line): both at end and beginning of the crack, respectively.

To evaluate the depressions, three of the seven previous sections (from *Figure 10*) were chosen for this plane cut analysis.

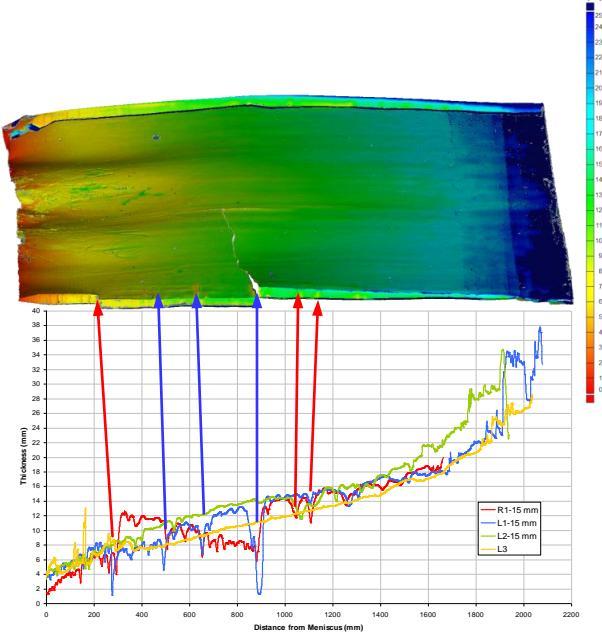
Figure 11. Results of the longitudinal sections compared with the 3D view

Results of these positions compared with the 3D view are shown in *Figure 11* for the longitudinal sections and in *Figure 12* for the transverse sections.

Again the lines show more clearly the reductions in thickness of the shell, indicating the localised and area reductions.

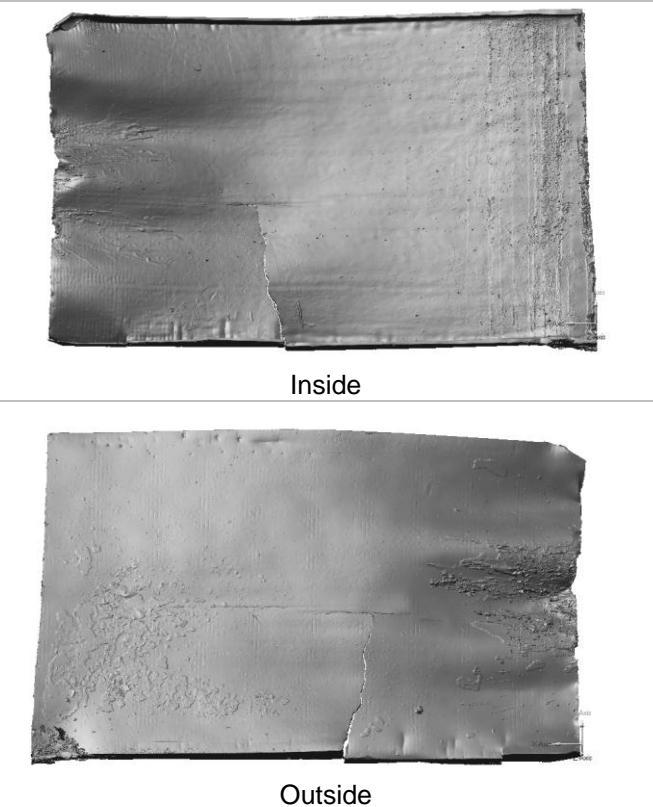
Figure 13. Surface profile of the breakout shell

The 3D laser measurement has also the possibility to evaluate the surface profile (smoothness) of the breakout shell (*Figure 13*).

Considering the localised reductions in thickness of the shell, it is interesting to see the inside and outside surface profiles of the breakout shell.

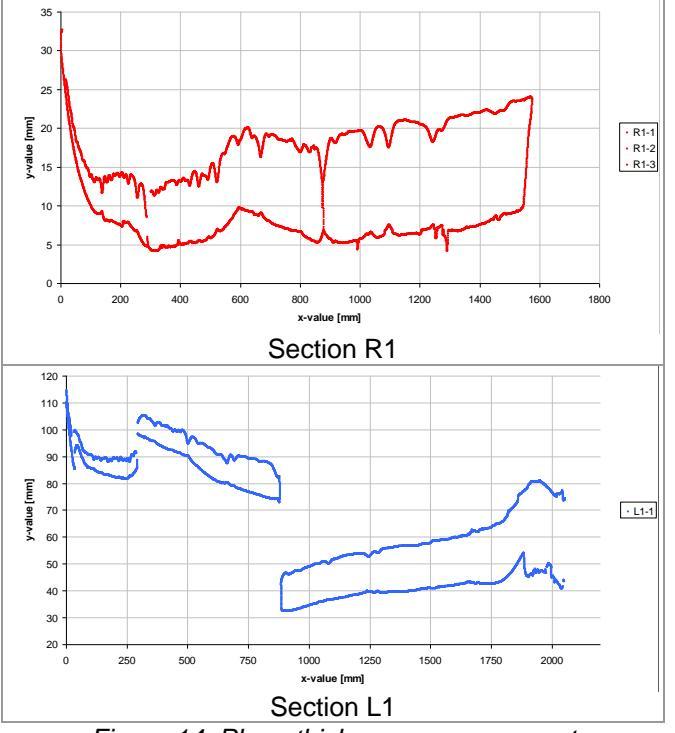
Figure 14. Plane thickness measurement

From the results of the surface study, a hypothetical plane cut can be used in the 3D results to evaluate the shell thickness.

In *Figure 14*, the two sections close to the breakout hole, R1 and L1, both show that the thinning of the shell (depressions) comes from the inside of the breakout.

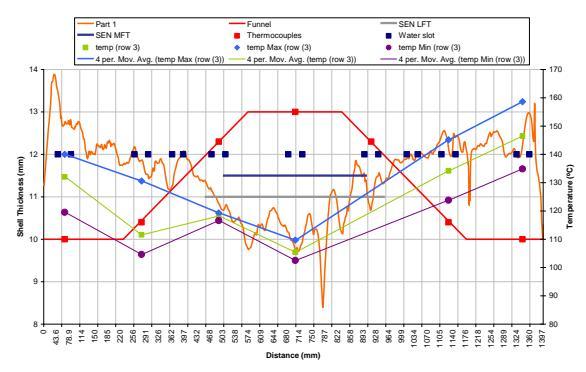
Figure 15. Thermocouples signals compared wit the shell thickness measured.

In *Figure 15*, the average value of the thermocouple signals during a period of 3 minutes (green line and green points), maximum (light blue line and light blue points) and minimum values (magenta line and magenta points); are compared with the shell thickness measured in the breakout shell (orange line from *Figure 10* and *Figure 12*).

In the figure the position of the water slots and Berthold sources (dark blue squares), funnel shape (red line), position of the thermocouples (red squares), position of the two SEN's types normally used(Grey and dark blue lines) are also drawn. From this picture it is clear that the thermocouples signals follows the same trend as the shell thickness. However there is no correlation with the shell thickness or the thinning and the mould features (water slots, Berthold, thermocouples position or funnel shape).

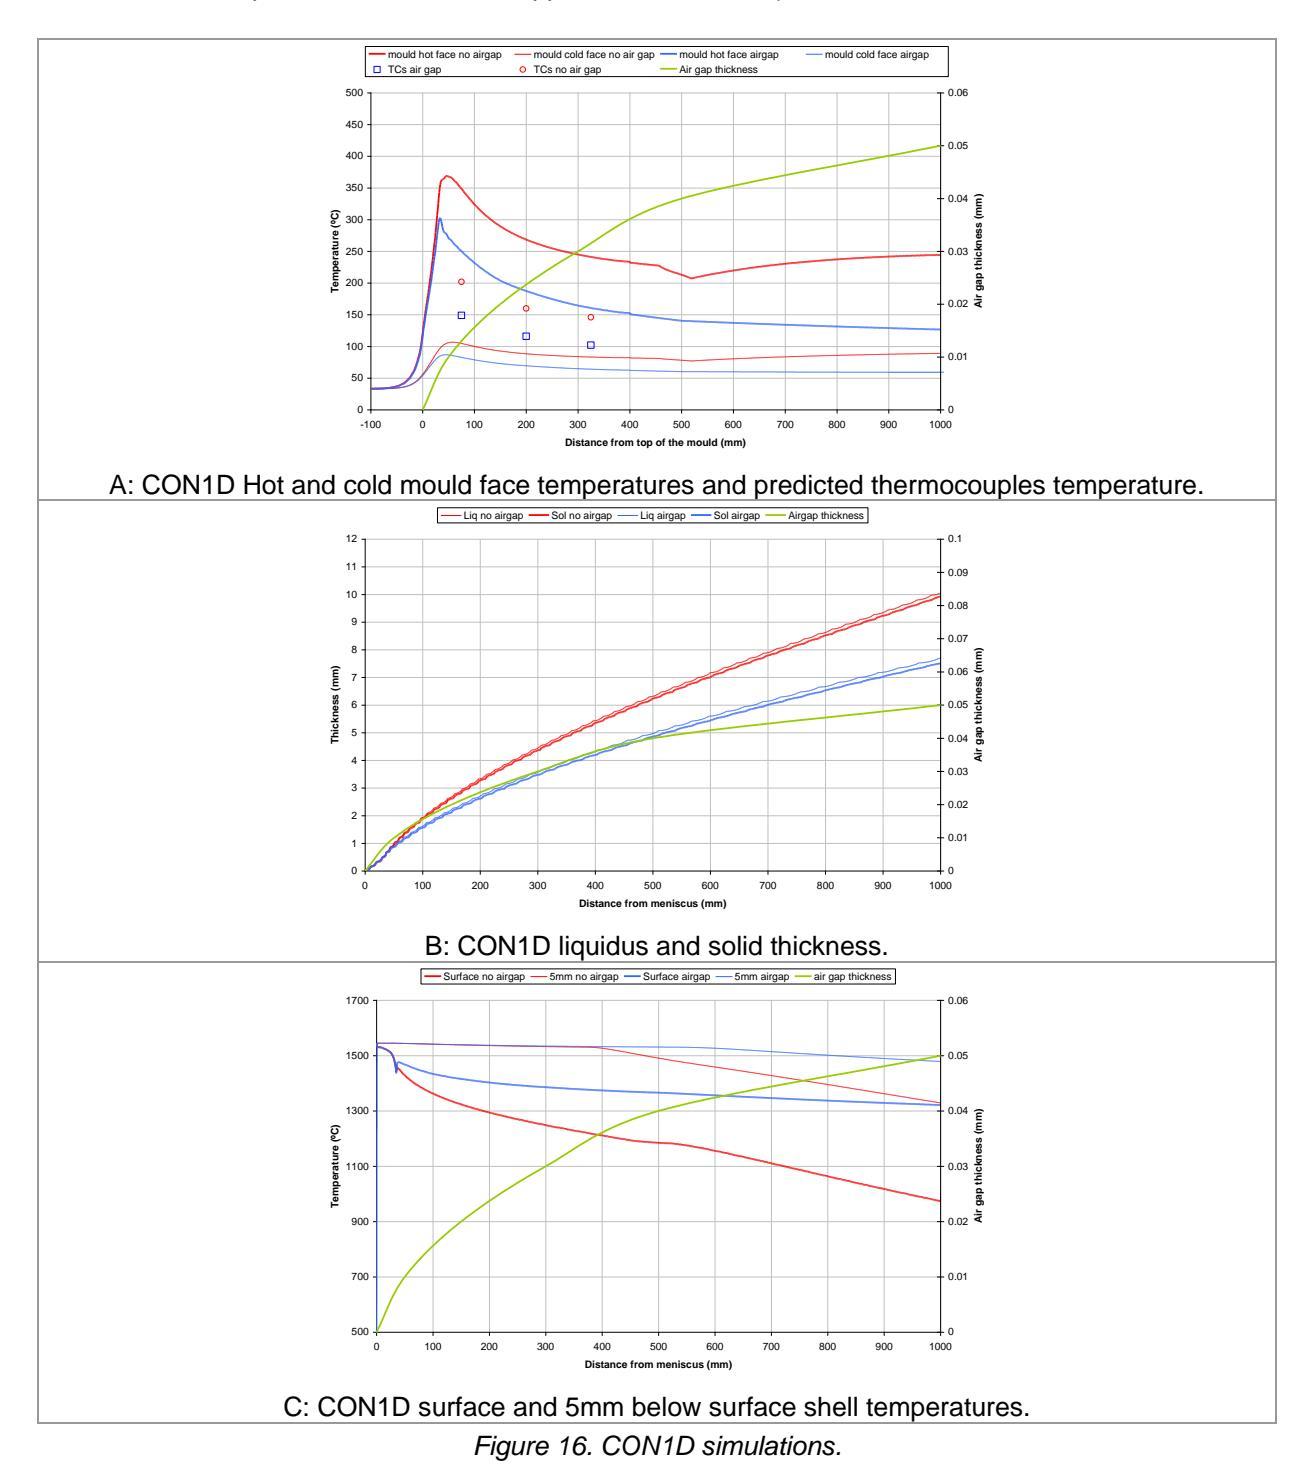
2- Simulation with an air gap following a parabolic increase in thickness from zero at meniscus and 0.05 mm at mould exit (green line in *Figure 16*, secondary Y axis).

From *Figure 16* it can be concluded that even a small air gap (maximum at mould exit: 0.05 mm) between the shell and the mould would have a remarkable effect on the solidification.

Due to the low conductive properties of the air (conductivity of 0.06 W/mK), as expected, the mould temperatures in the presence of an air gap will be lower than with no air gap (Red lines for air gap simulation and blue lines for no air gap in *Figure 16*  A); the same behaviour will have the thermocouple signals (red circles for no air gap and blue squares for air gap simulation in *Figure 16* A)

Consequently, the shell will be thinner when an air gap is present between the steel and the mould (Blue line for air gap simulation and red lines for no air gap in *Figure 16* B).

Moreover, the surface temperature of the shell in the air gap simulation is hotter than with no air gap; and the temperature 5 mm below surface, as well. In addition, the temperature difference between the surface and 5mm under the surface is smaller in the simulation with air gap than in the no air gap case (Blue lines for air gap simulation and red lines for no air gap case in *Figure 16* C).

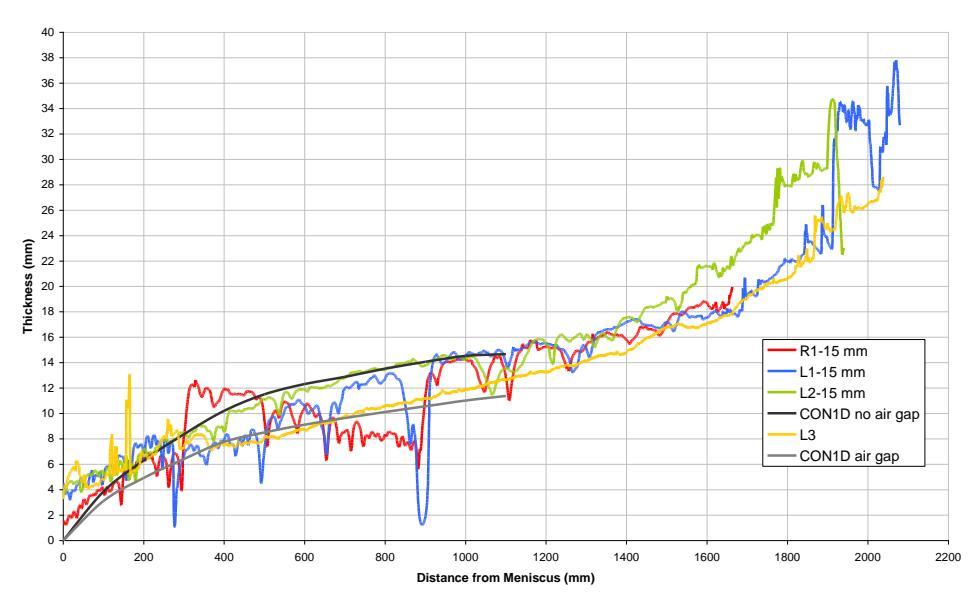
Figure 17. Predicted and measured Shell thickness

*Figure 17* gives the predicted shell thickness at both steady state and transient conditions. The generally close match with the transient predictions tends to validate the hypothesis. The underpredicted shell thickness near the meniscus is likely due to a short interval of increased liquid flow into the mould after the breakout started and before level control and flow were shut off. This would have allowed the liquid level to move downward with the top of the breakout shell for a short time interval (not included in the calculations), thus providing additional solidification time at the very top of the breakout shell. This is a very commonly observed effect in breakout shells [3].
